RAAF AE2100D3 Engine Health Management

SGT Andrew Wade CSC
MScTech (Aviation)
AE2100D3 EHMS
ALSPO Propulsion Systems Engineering
Royal Australian Air Force

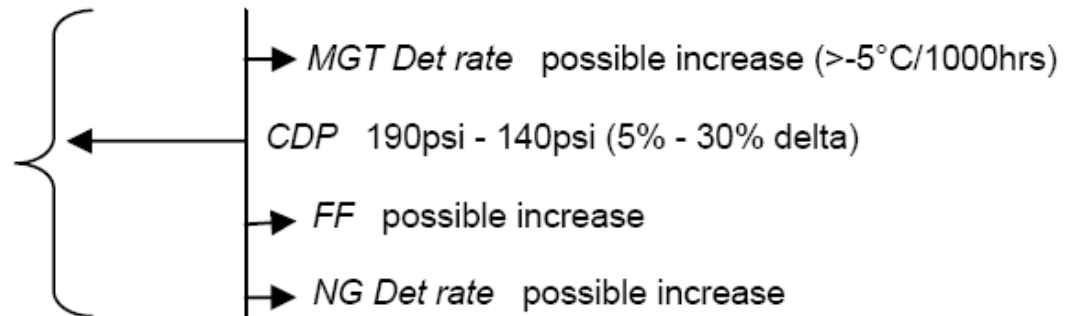
Partially open 10th Stage Acceleration Bleed Valves²
(CDP Step Change)

CDP Step Change <30% Delta

² No real noticeable effect on performance (corresponding MGT / FF / NG shift) until MGT Margin is <5°C or CDP is <140 psi (>30% delta). The most likely contributor to this fingerprint is a pressure drop across 14th stage control air plumbing (leak in the CDP system) causing 10th Stage Acceleration Bleed Valves (ABV) to partially open. This leak in the CDP system is caused by worn ABV rings and/or springs, a split/leaking compressor wash air line or an excessively worn piston in the Compressor Acceleration Bleed Valve Control Valve (CABCV). Fault is confirmed by using compressed air to leak check the 14th Stage control air plumbing via the compressor wash air line fitting located in drain mast and the at fault item is replaced.

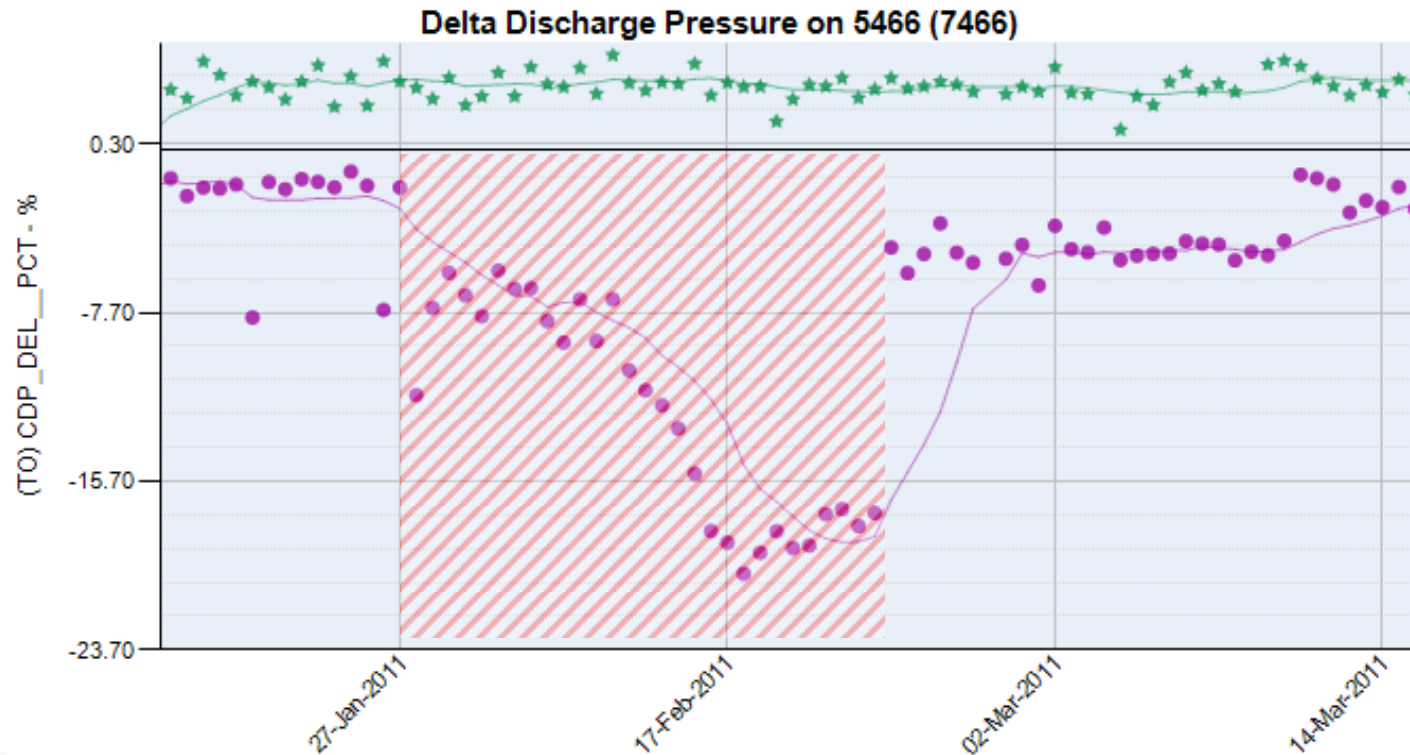
Example. 27 Jan - 20 Feb, 2011

CDP Step Change <30% Delta - Partially open ABVs

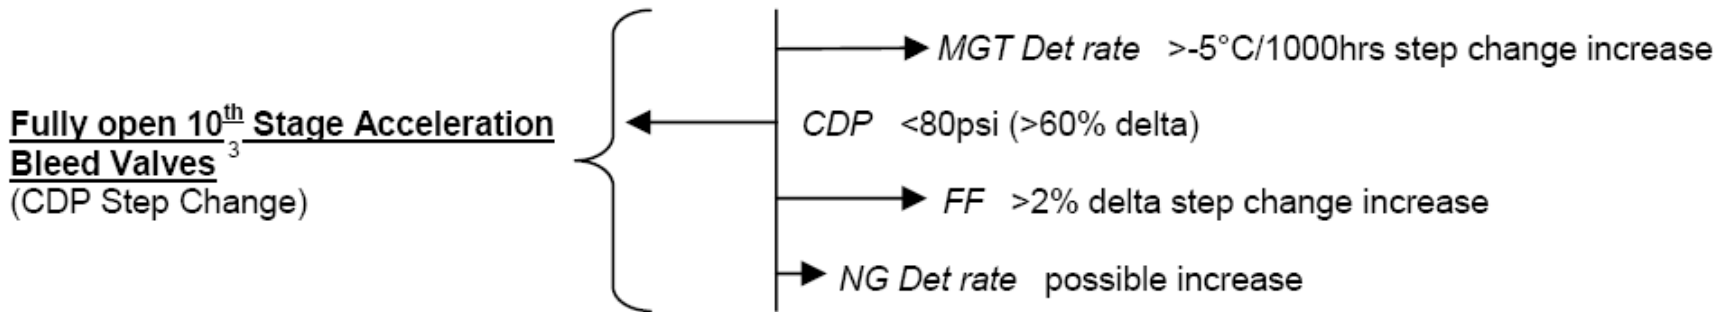
CDP Step Change >60% Delta

³ Noticeable effect on performance as evidenced by a corresponding MGT margin and FF shift. The most likely contributor to this fingerprint is complete pressure loss across 14th stage control air plumbing causing 10th Stage Acceleration Bleed Valves (ABV) to fully open. This is caused by loose/disconnected 14th stage control air plumbing, loose/disconnected compressor wash air line (maintenance error) or one of the aforementioned plumbing has completely ruptured (structural failure). Fault is confirmed via visual inspection for loose/disconnected fittings or structural defects. If not able to be identified, compressed air is used to leak check the 14th Stage control air plumbing via the compressor wash air line fitting located in drain mast and the at fault item is replaced.

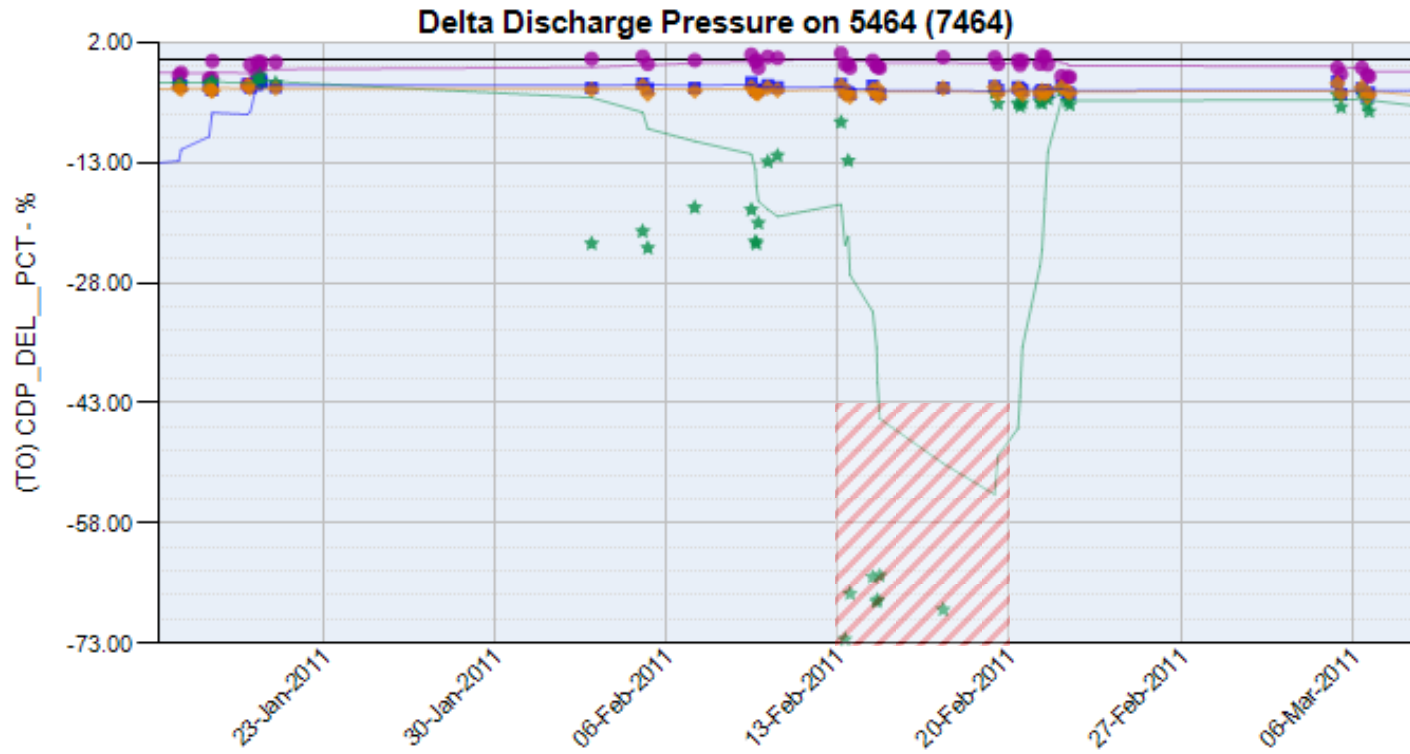
Example. 13 - 20 Feb 2011

CDP Step Change 70% Delta - Fully open ABVs

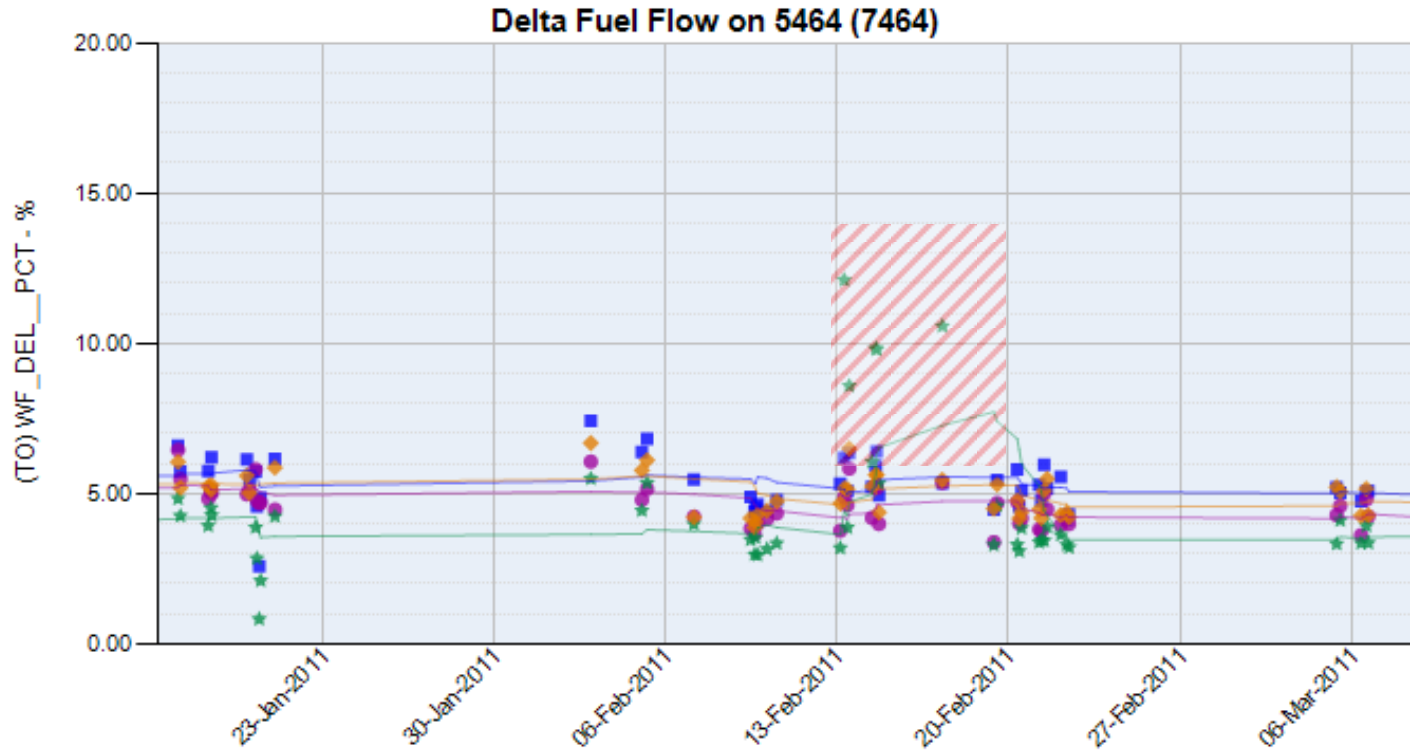
Fuel Flow - 6% Delta increase

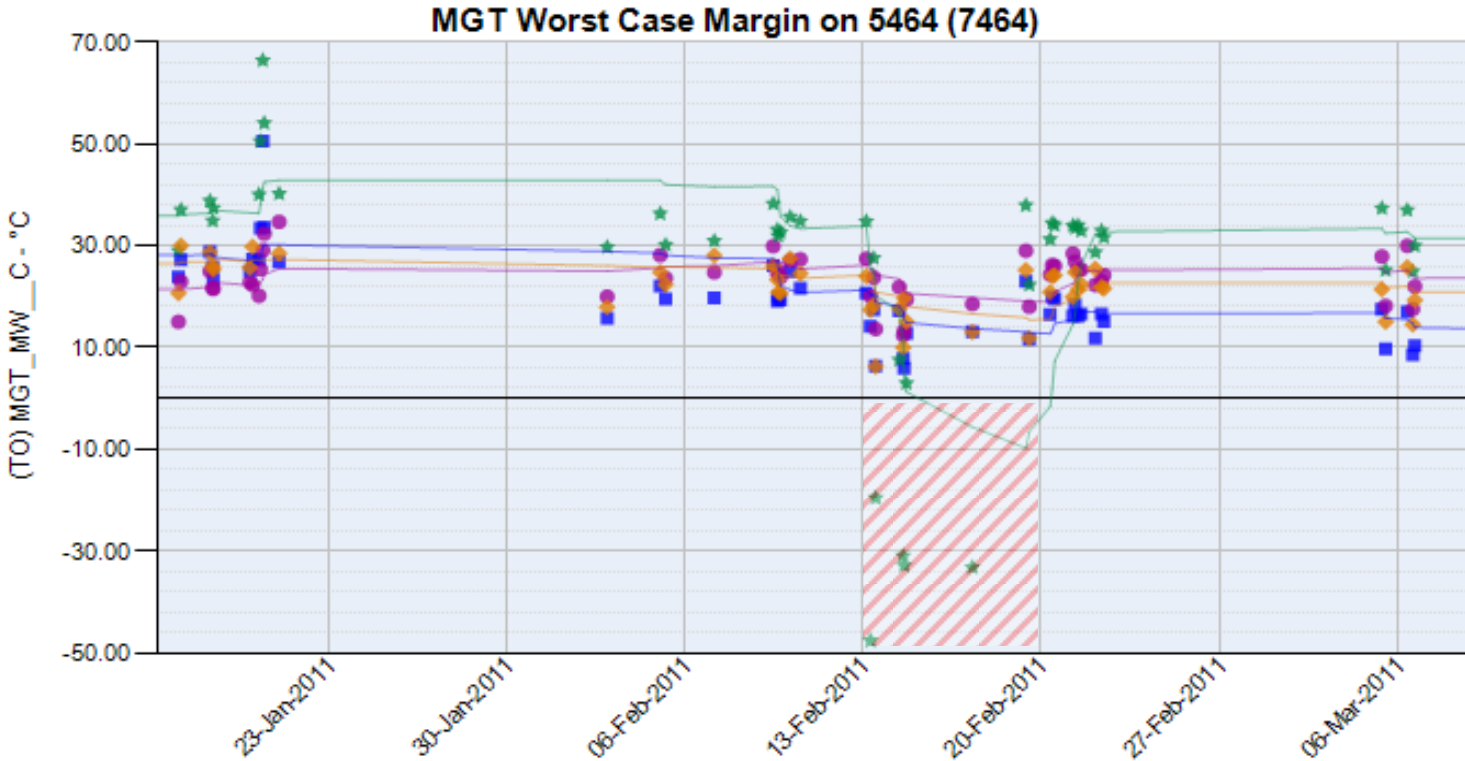
80°C MGT Margin loss + Nacelle O/Heat ACAWS (Mission Abort)

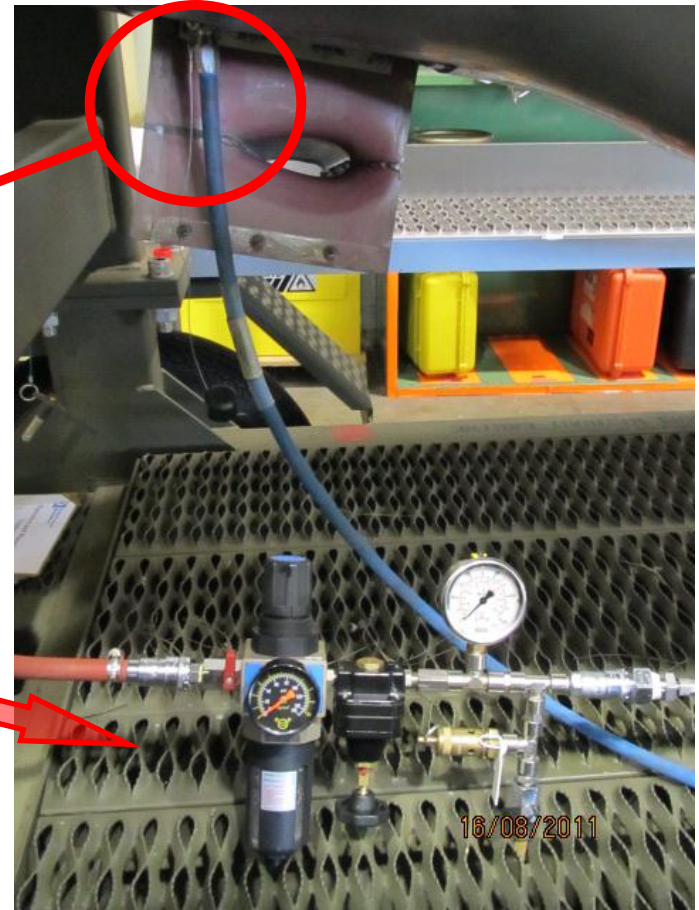
14th Stage ABV control air plumbing

Compressed Air Leak Test

Compressor wash air line connected to drain mast

Compressed air supply regulated to 60PSI

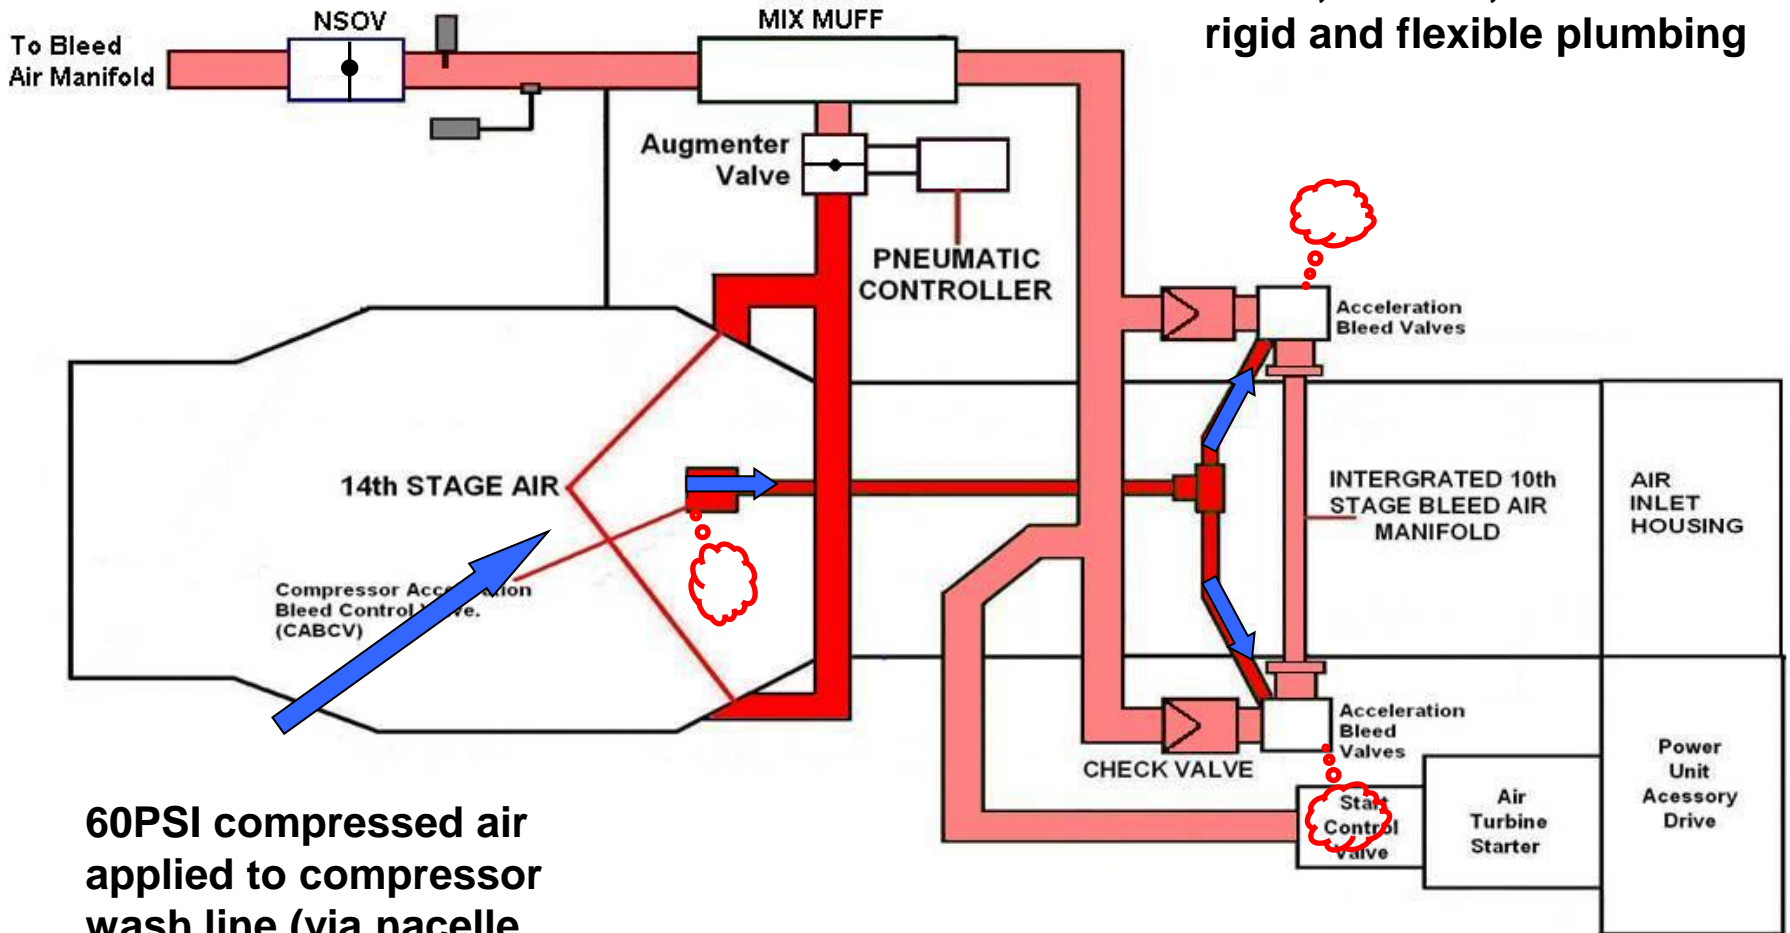
14th Stage ABV control air plumbing

Leak check using compressed air

Leak checks carried out on ABVs, CABCV, and associated rigid and flexible plumbing

60PSI compressed air applied to compressor wash line (via nacelle drain mast)

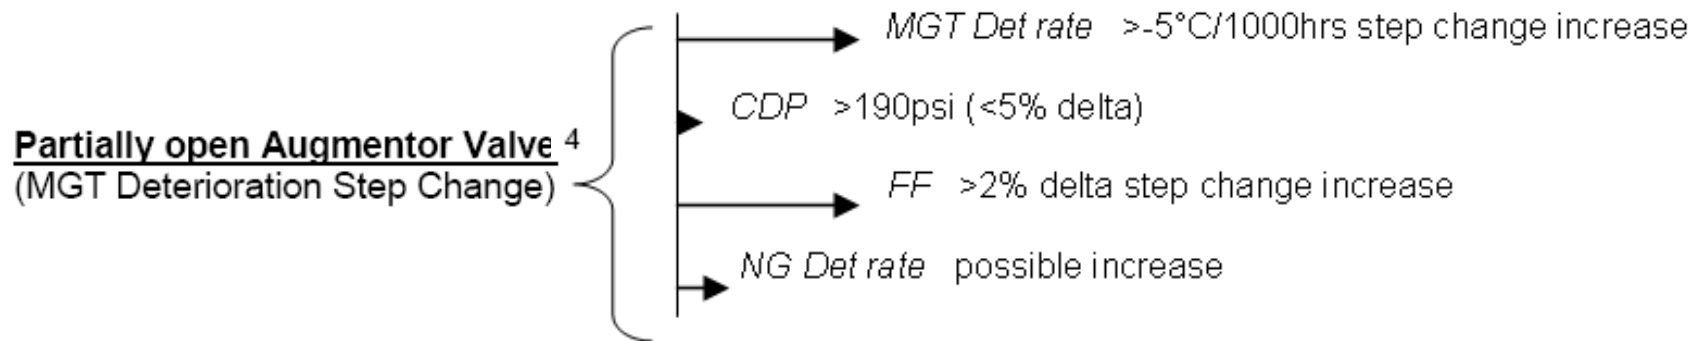
Step Change MGT Margin Loss $>15^{\circ}\text{C}$

⁴ This fingerprint will be characterised by a rapid fall in hours remaining until zero MGT margin over a short period of time. For example, if an engine displays a reduction in hours until zero MGT margin from >5000 hours to 1500 hours over a period of one week, and this fingerprint is displayed, then the most likely contributor is the 14th Stage Augmentor Valve being partially open at all power settings. This failure mode disrupts essential 14th stage turbine cooling air from the compressor, thereby increasing MGT and accelerating turbine degradation. When fault is confirmed (via 14th stage duct bleed air test kit), Augmentor Valve is replaced.

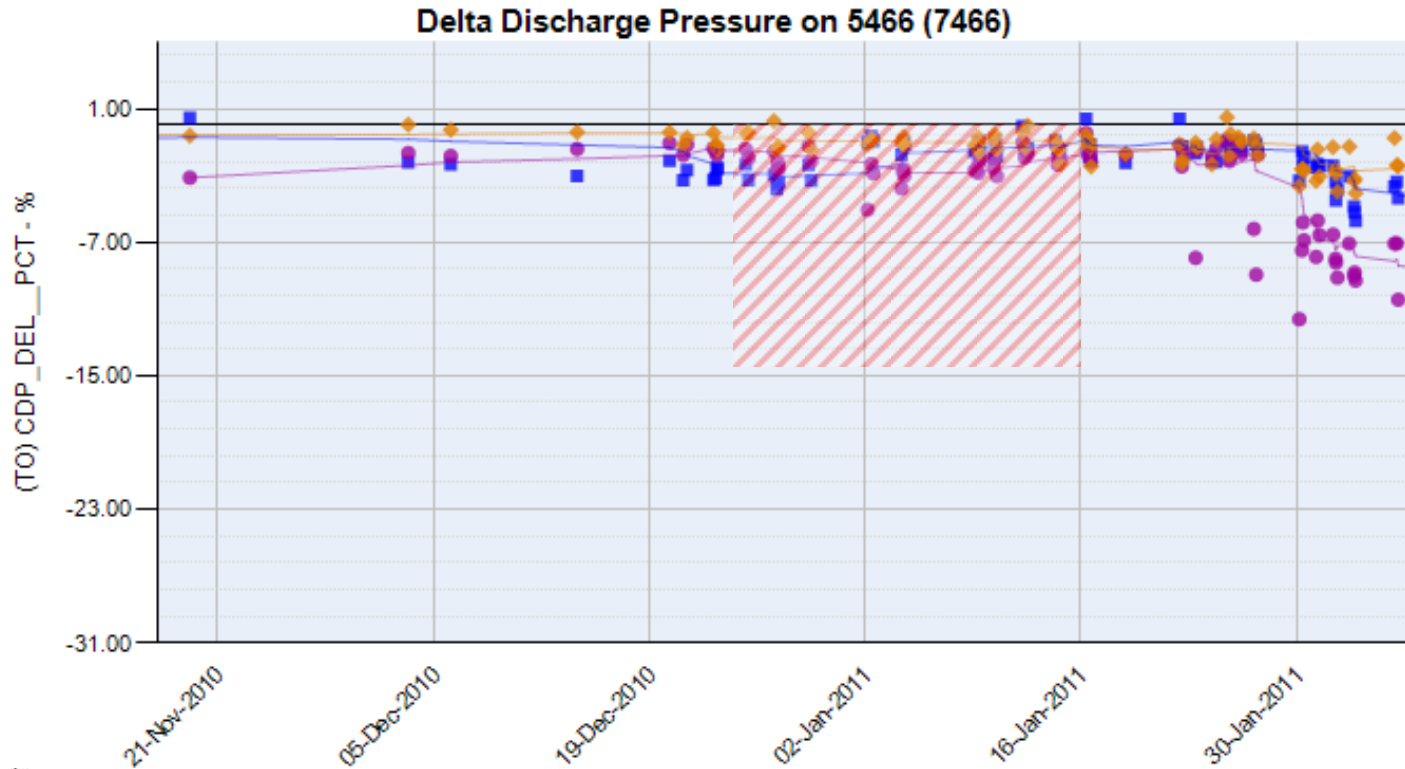
Example. 26 Dec 2010 - 16 Jan 2011

25°C MGT Margin Loss – Partially open Augmentor Valve

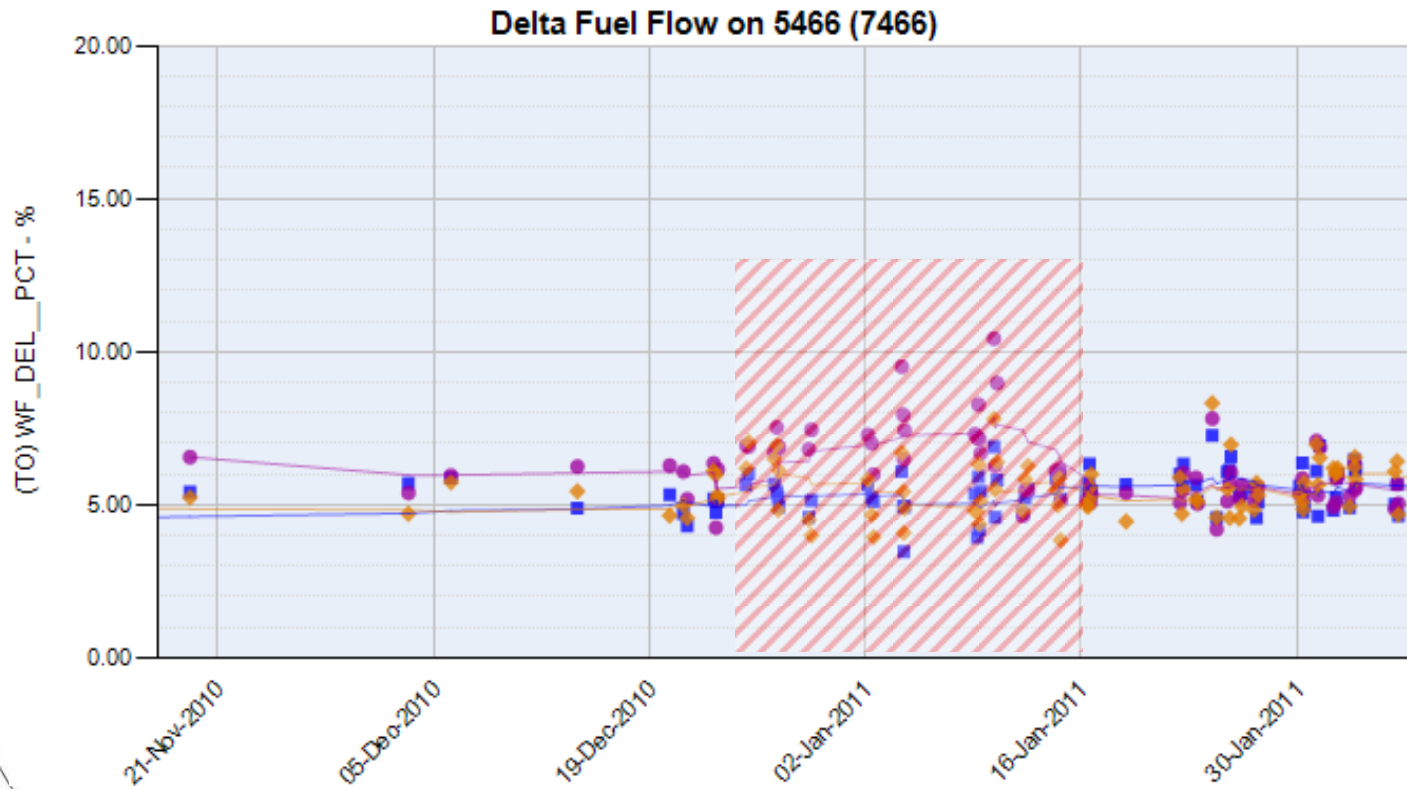
Fuel Flow - 5% Delta increase

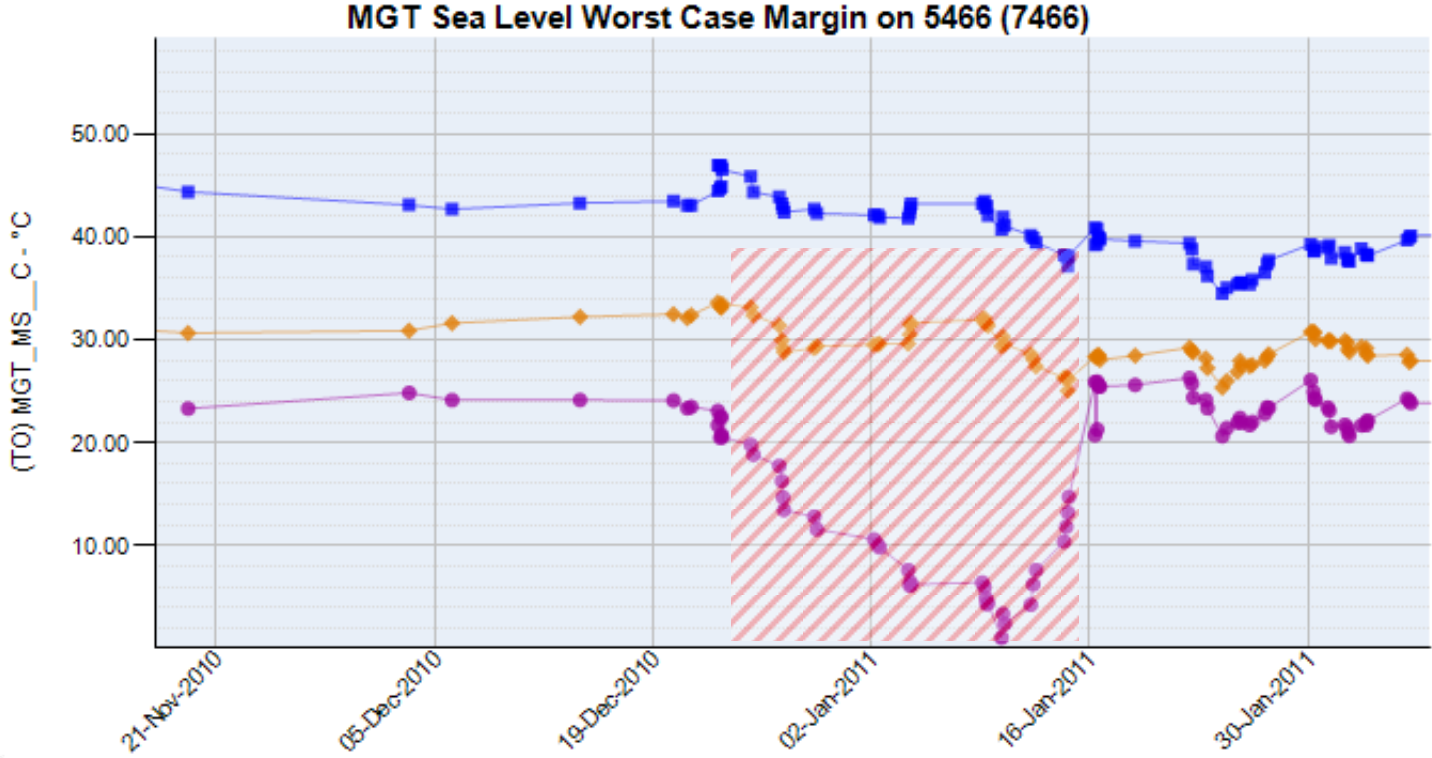
25°C MGT Margin loss – Augmentor Valve Replaced

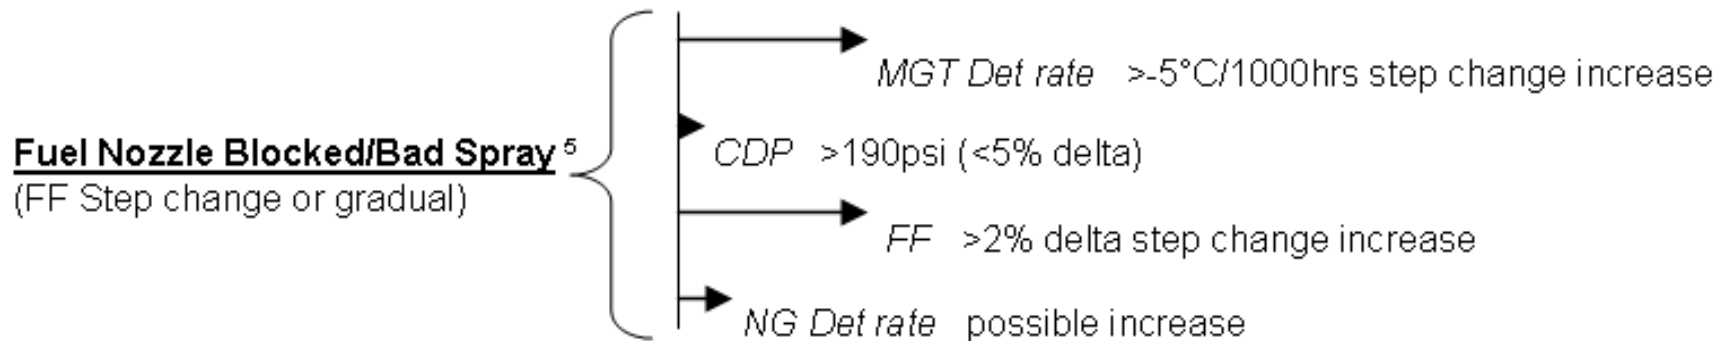
Step Change MGT Margin Loss $>15^{\circ}\text{C}$

⁵ This fingerprint will be characterised by a gradual fall in hours remaining until zero MGT margin over a relatively short period of time. For example, if an engine displays a reduction in hours until zero MGT margin from >5000 hours to 1500 hours over a period of two/three weeks worth of operation, and this fingerprint is displayed, then the most likely contributor is blocked/coked fuel nozzles causing bad spray patterns and inefficient burn. When fault is confirmed (via borescope inspection for fuel nozzle condition), fuel nozzle set (x16) is replaced.

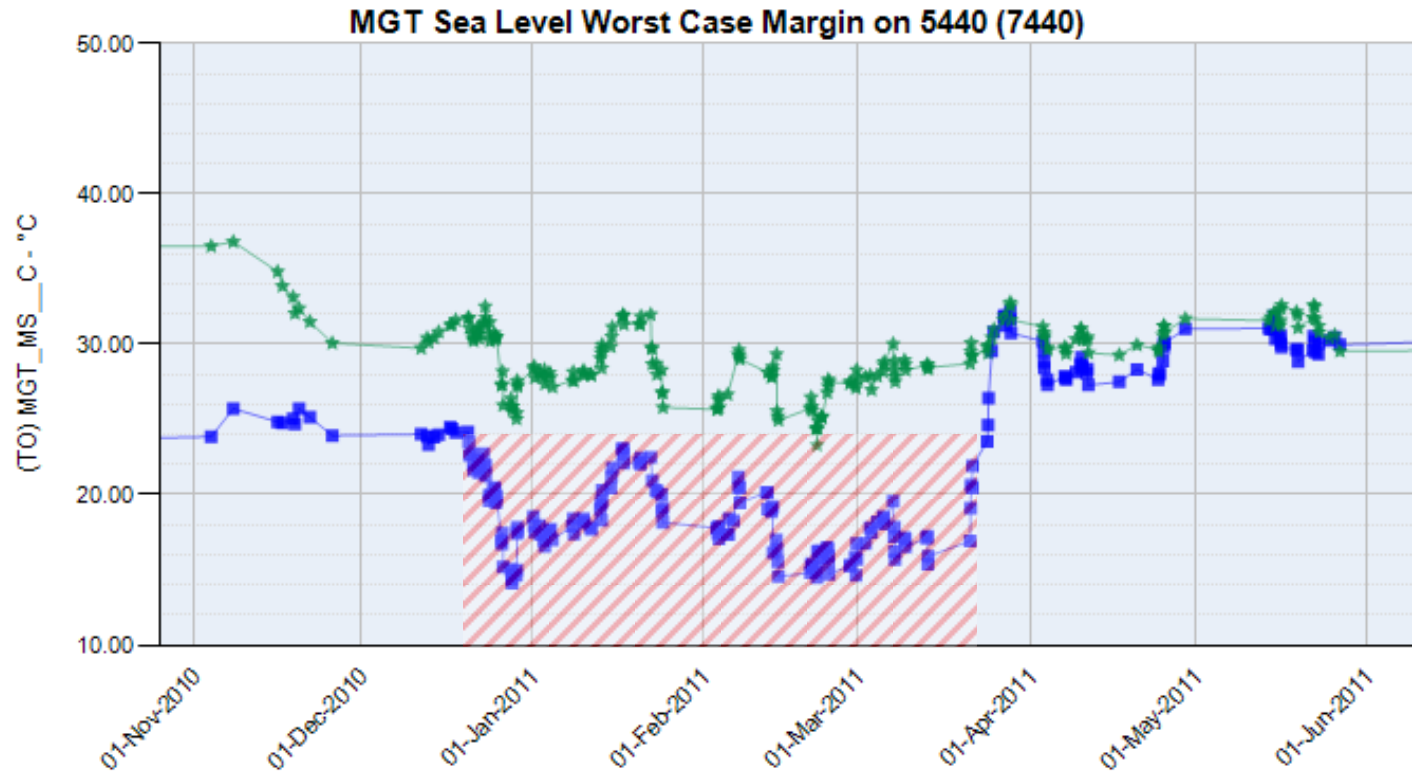
Example. 20 Dec 2010 - 20 Mar 2011

15°C MGT Margin Loss – Coked Fuel Nozzles

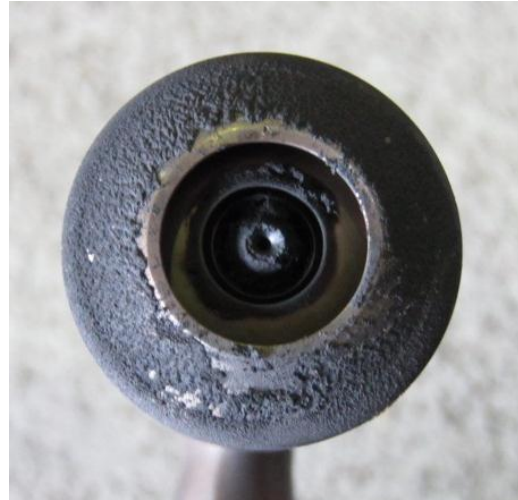
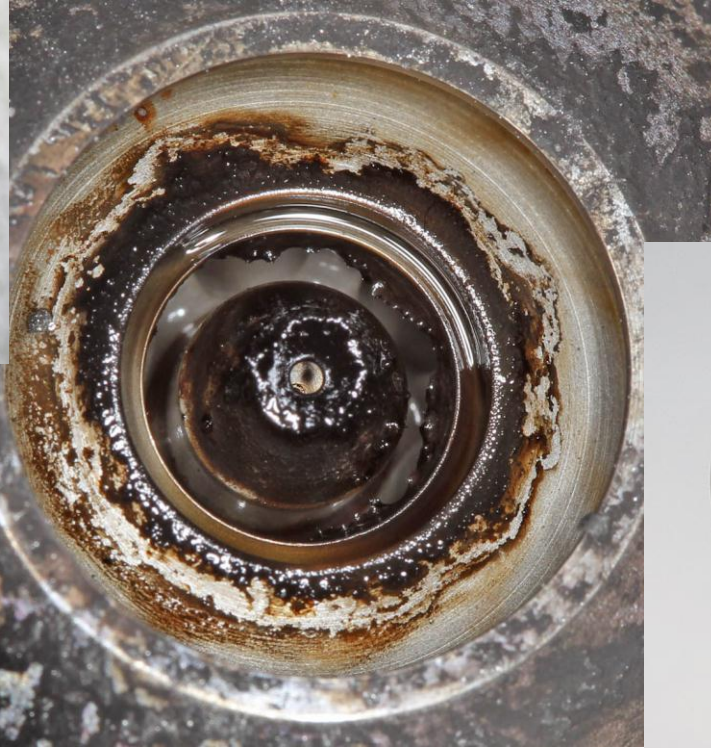
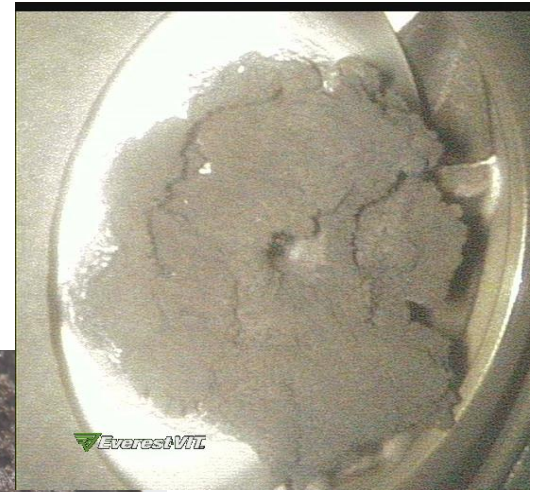
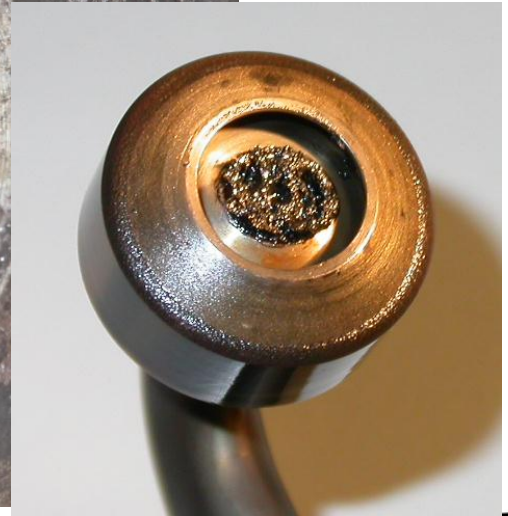
Coked Nozzles

- Coked fuel nozzles causing $>15^{\circ}\text{C}$ MGT Margin loss are all Piloted Orifice variant. (No occurrences so far related to PuAB)
- Coked nozzles - confirmed via borescope inspection.
- 20 Fuel Nozzle sets (x 16) removed in last 12 months for this failure mode.
- All removed fuel nozzle sets had accrued ~ 1000 hours since last Bay Service (2400 hour BS interval)

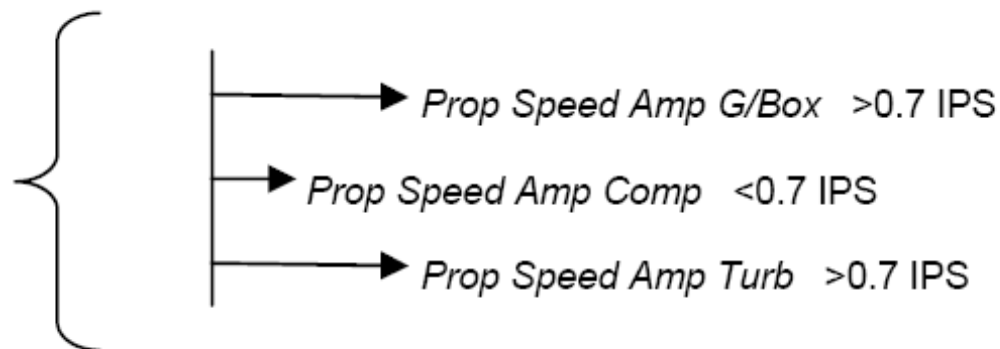
Propeller out of balance²
(Step change or gradual)

² This fingerprint is characteristic of an actual vibration (not indication error), in that a minimum of two of the three sensors are indicating vibration readings >0.7 IPS. An engine that has vibration readings within the acceptable range should not have readings increase out of range (over a minimum of two sensors) unless the propeller has been replaced, there is a physical change within the propeller or the engine mounts are deteriorating. All step change vibration increases should be investigated for any unserviceabilities that have been recorded or maintenance that has been recently conducted that could have an effect on vibration readings. For example, if an engine's vibration readings over two sensors increase from <0.5 IPS to > 0.7 IPS over a few operations (step change), then the propeller may have been recently replaced, have oil leaking into the hub or have developed an excessive grease leak from the blade root/s. A gradual increase from <0.5 IPS to > 0.7 IPS would be indicative of a minor grease leak from the blade root/s or deteriorating engine mount/s.

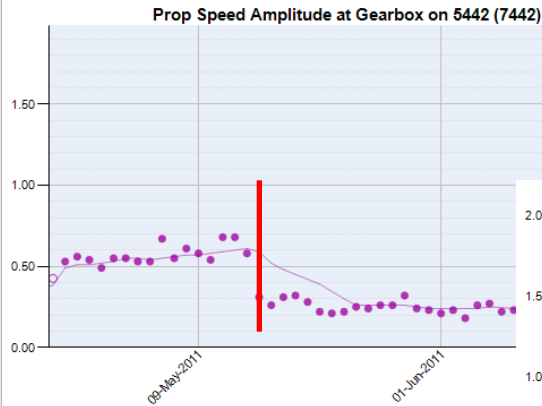
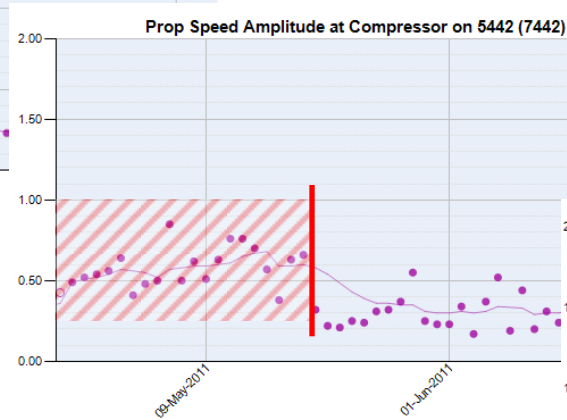
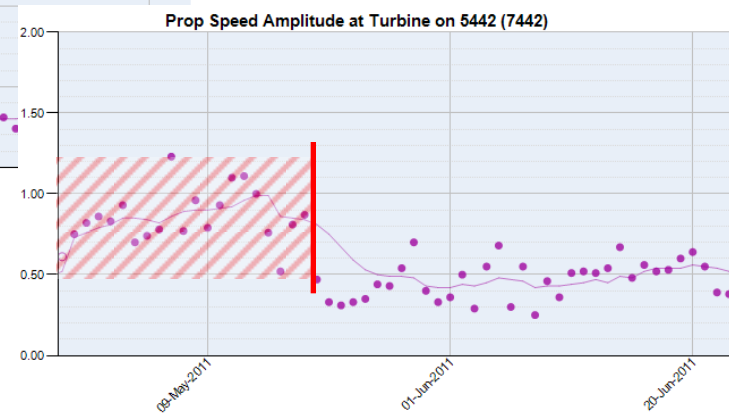
Example. 1 Apr – 16 May 2011

Actual Vibration – Prop out of Balance

2 of 3 sensors >0.7 IPS

~0.4 IPS reduction

PBS Solution 16 May 11

– Software Solution Applied

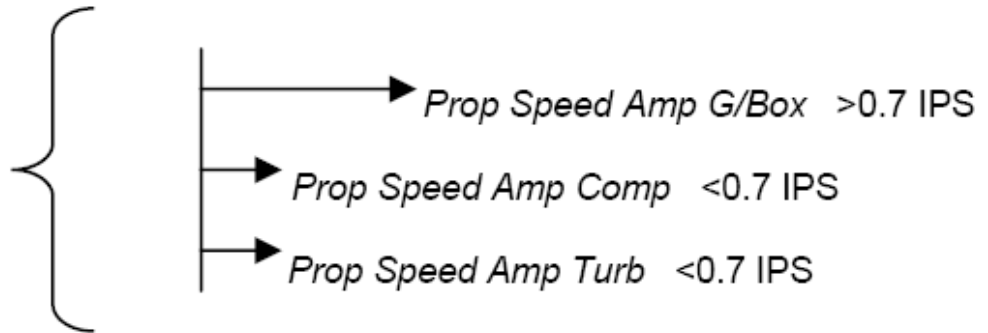
Vibration Indication error³
(Step change)

³ This fingerprint is characteristic of a vibration indication error, in that only one of the three sensors are indicating vibration readings >0.7 IPS. All step change vibration increases over a single sensor should have maintenance action performed as soon as possible to prevent an in flight vibration event (IFSD). Single sensor deviation will appear erratic by not following the data point movement pattern of the other two sensors. For example, if an engine's vibration readings over one sensor increase from <0.5 IPS to > 1.0 IPS over a few operations (step change), then there is an error with the indication system. Fault would be confirmed by visual inspection of the offending sensor's receptacle for contamination or damage, harness plug for security or damage. If there is no visible contributor, sensor would be replaced.
