20th Australian International Aerospace Congress

DSTG Planet Gear Rim Crack Propagation Test

The Defence Science and Technology Group (DSTG) recently conducted a planet gear fatigue crack propagation test in a Kiowa 206B-1 helicopter main rotor gearbox (4-planet version). This test was designed to explore the phenomenon of fatigue cracking in thin-rim helicopter planet gears where the gear body incorporates the outer raceway of the planet bearing, and the crack initiates at or near the raceway surface and propagates through the gear body instead of a gear tooth. The crack was initiated from an electric discharge machined (EDM) notch in the planet gear rim and propagated from one side of the gear to the other between two gear teeth. This type of fault is challenging to detect reliably due to the lack of liberated wear debris, and the relatively weak vibration signature (using classical vibration fault detection methods) until the crack reaches across a large proportion of the gear body. As a result, this can lead to the catastrophic failure of the main rotor gearbox. The details of the test, selected results, and other issues are presented and discussed. A vibration dataset genera

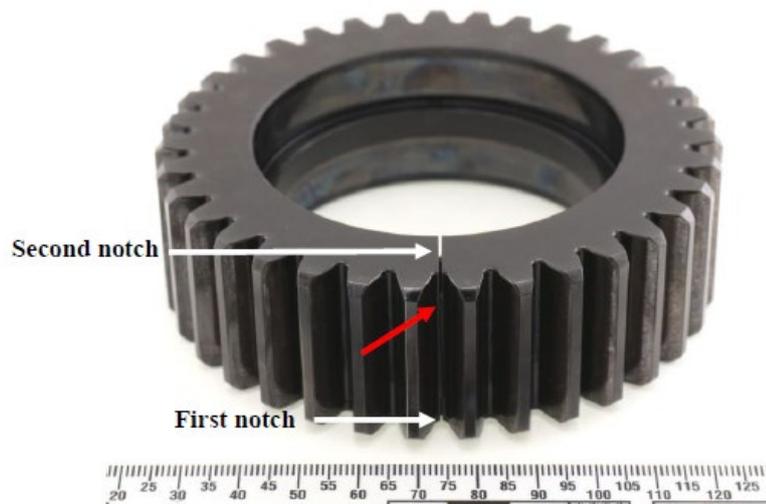
To initiate the fatigue crack, two stress-raising EDM notches were inserted in the gear, as shown in Figs. 1 and 2. Two notches were used because the first (smaller) notch did not initiate a crack during the first 146 load cycles of the test. This was confirmed by disassembly of the gearbox and eddy-current non-destructive testing of the planet gear at that time. A second (larger) notch was then added in the same plane as the first on the opposite side of the gear. A fatigue crack was successfully initiated and propagated from the second notch over load cycles 147 – 241. The notches were approximately 0.14 mm to 0.20 mm wide, with the second notch visually wider than the first. The fillet radius at the bottom of the notch was assumed to be 0.02 mm. The notch shapes and sizes were guided by two sets of finite element analysis (FEA) [8, 9]: one conducted pre-test, and one after the disassembly at 146 cycles. The first FEA predicted a peak local stress at the notch just below the yield strength of the gear material. The second FEA predicted a peak stress in the second notch above the yield strength.

Fig. 1: The planet gear (crack indicated by red arrow)

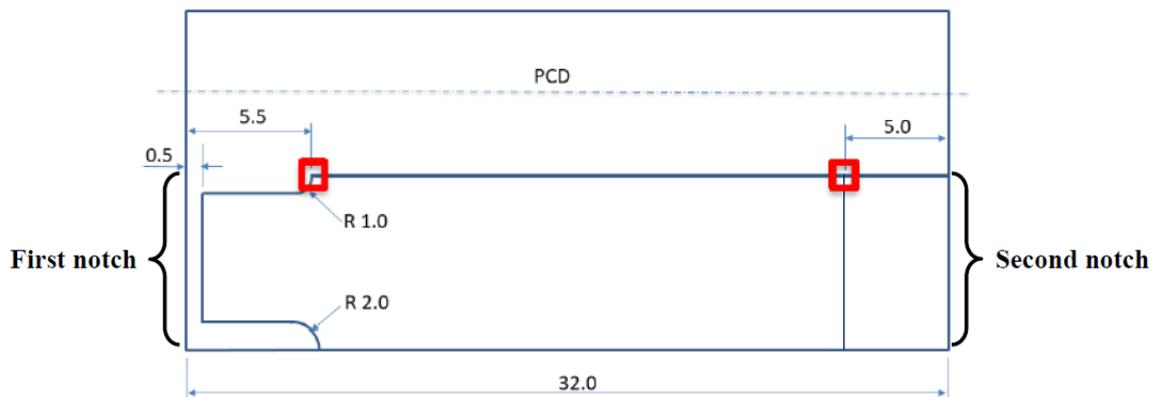
Fig. 2: Planet gear notches (dim. in mm); dashed line indicates the approx. position of the pitch circle diameter (PCD); FEA stress extracted from red highlights [10]

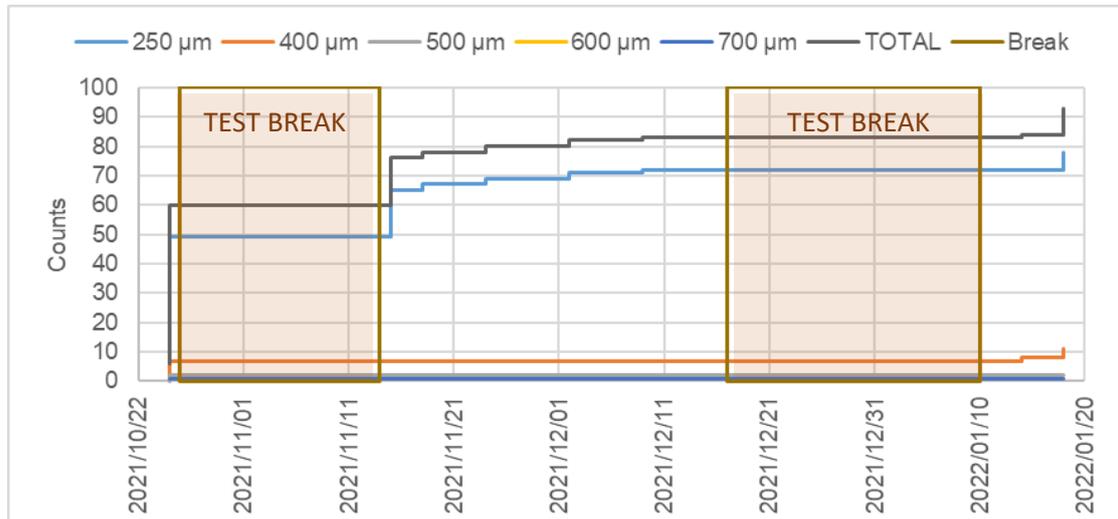
The ferromagnetic debris counts detected by the inductive wear debris monitor for the second part of the test are shown in Fig. 4. Ignoring the major breaks in testing (shaded), it can be seen that the largest count increases were detected on the first two runs after gearbox reassembly (25 Oct & 15 Nov); however, this was considered normal behaviour following reassembly. There was then a long relatively stable period leading up to the last two test days, with only a few counts accumulating in the smallest bin size. The final 10 particles (in the 250 μm and 400 μm bins) may have been liberated as the crack broke through to the first notch which, by that time, was slightly misaligned with the position of the crack front. It can be seen in Fig. 6 that some gear material was liberated from the bearing raceway side of the gear. No non-ferromagnetic particles were counted during this period.

Fig. 4: Ferromagnetic debris counts (no particles in bins above 700 μ m)

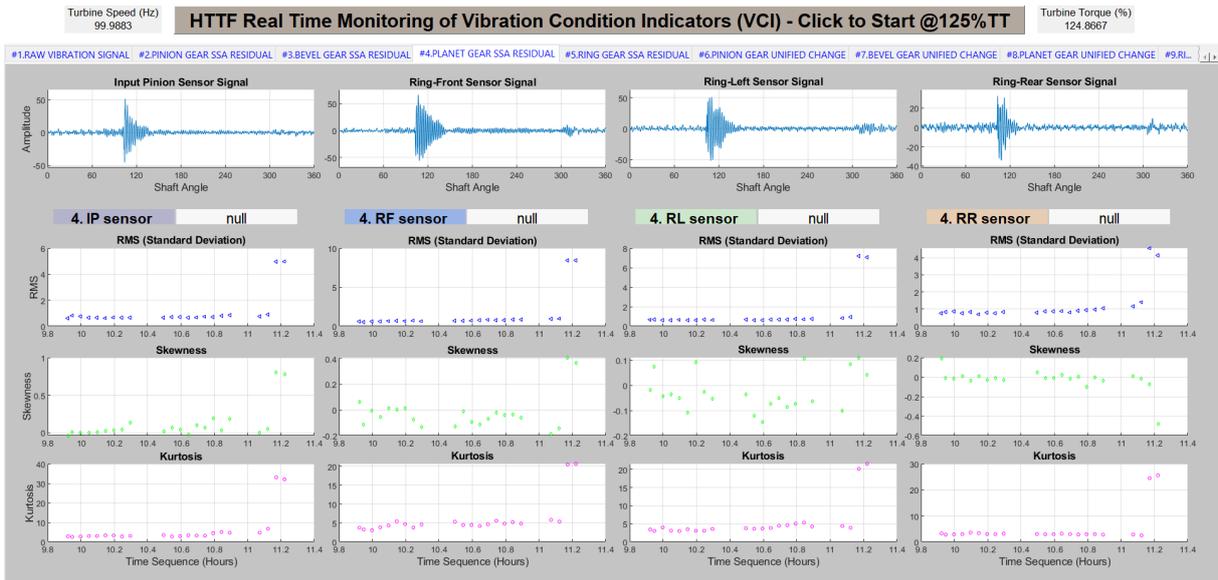
The (near) real-time vibration monitoring was based on a number of relatively standard condition indices (CIs) calculated from the raw vibration data and the synchronous signal averages. Fig. 5 is a reconstruction of the GUI display on the final day of testing that illustrates the point where the crack broke through to the first notch. While this obviously produced a very large indication at the point of breakthrough, the trends of all the monitored CIs leading up to this point were much weaker. The test was then terminated in a controlled manner as quickly as possible. Firstly, the torque was reduced to zero, then the speed was reduced to zero.

Fig. 5: Real-time GUI indicators for the final test day showing step change towards the end rows 1–4: = planet gear residual signals, residual RMS, residual skewness, residual kurtosis cols 1–4: input pinion, ring-front, ring left-side and ring-rear accelerometers

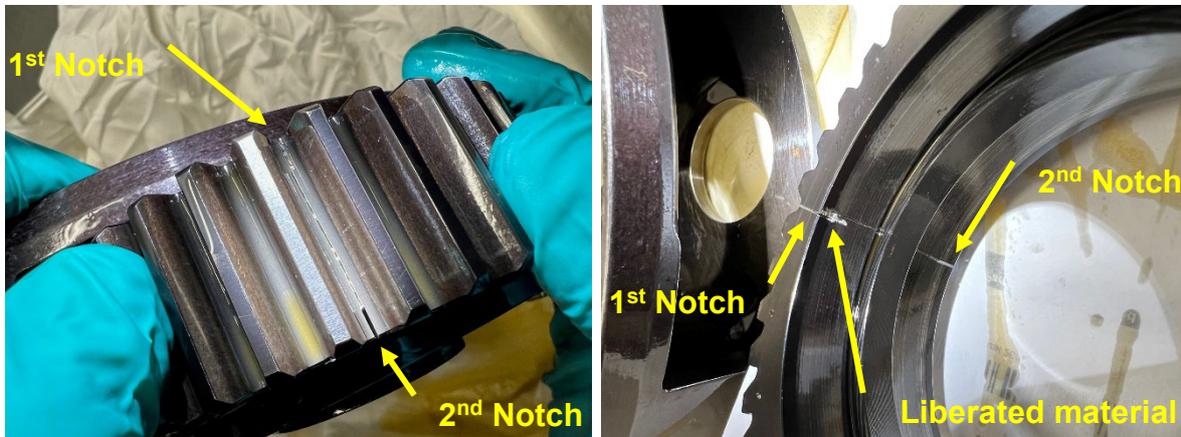
The cracked planet gear is shown in Fig. 6 just after the completion of the test and removal from the gearbox. It was clearly evident that the crack had propagated across the entire gear. When sectioned, the gear revealed a complex fracture surface (Fig. 7) with multiple fatigue origins along the edge of the second notch [10]. Enlarged views of the two opposing fracture surface faces are shown in Fig. 8. Examination of the fracture surface was challenging because the fatigue progression marks were not clear, as is typical for steel fatigue fractures. No identifiable fatigue markings could be seen originating from the first notch. Only 65 cycles could be identified in the crack initiated from the second notch: cycles 148-158 (from SEM images); and cycles 186-201 and 204-241 (from optical microscope images). The fracture surface analysis yielded the crack propagation shown in Fig. 10. It can be seen that the growth rate was relatively slow until around cycle 180. There was a relatively linear growth rate through cycles 186 to 232, and then a rapid acceleration from there to the final cycle.

Fig. 6: Cracked planet gear outer (left) and inner (right) views

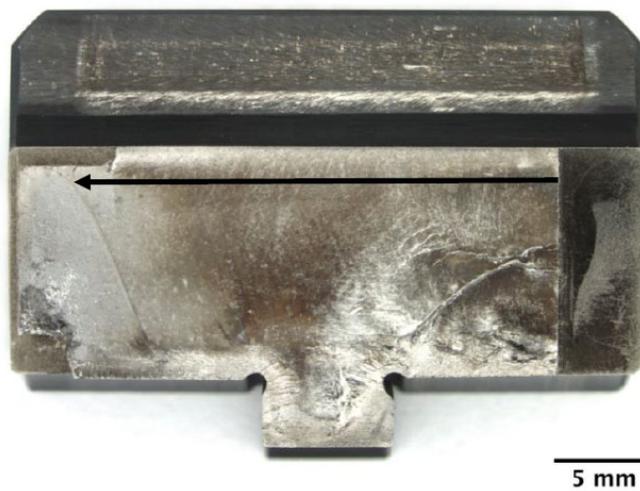
Fig. 7: Overall view of the fracture surface – the arrow indicates the approx. crack length measurement location and points to the final curved beach mark (the low load of cycle 241)

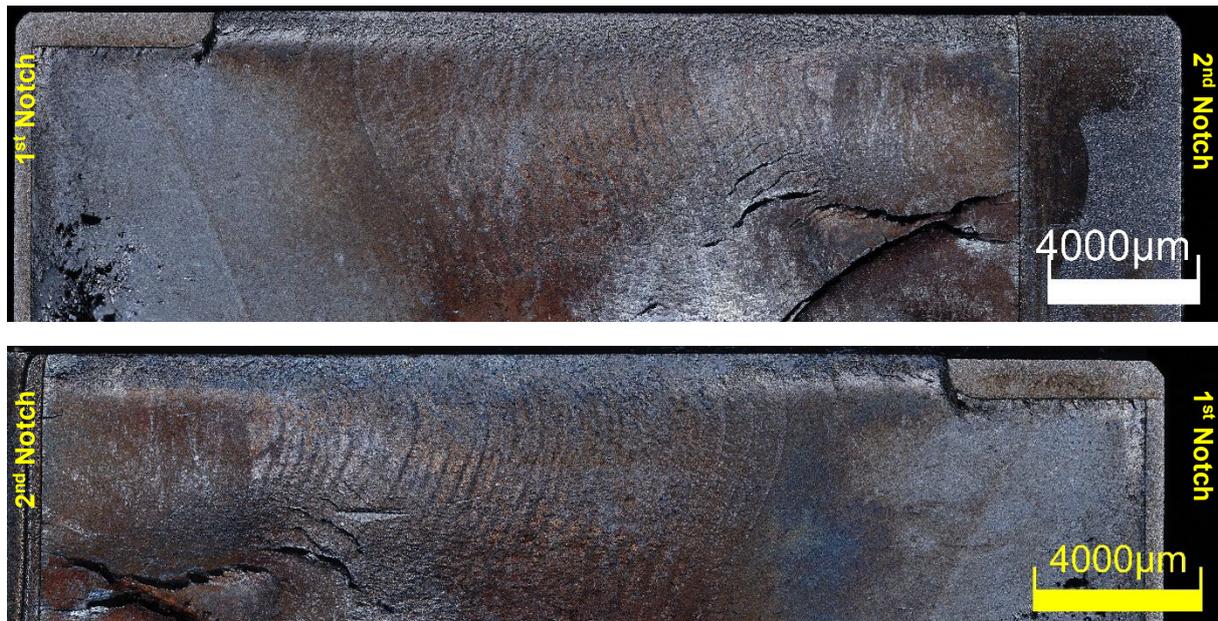
Fig. 8: Enlarged views of the two opposing fracture surface faces

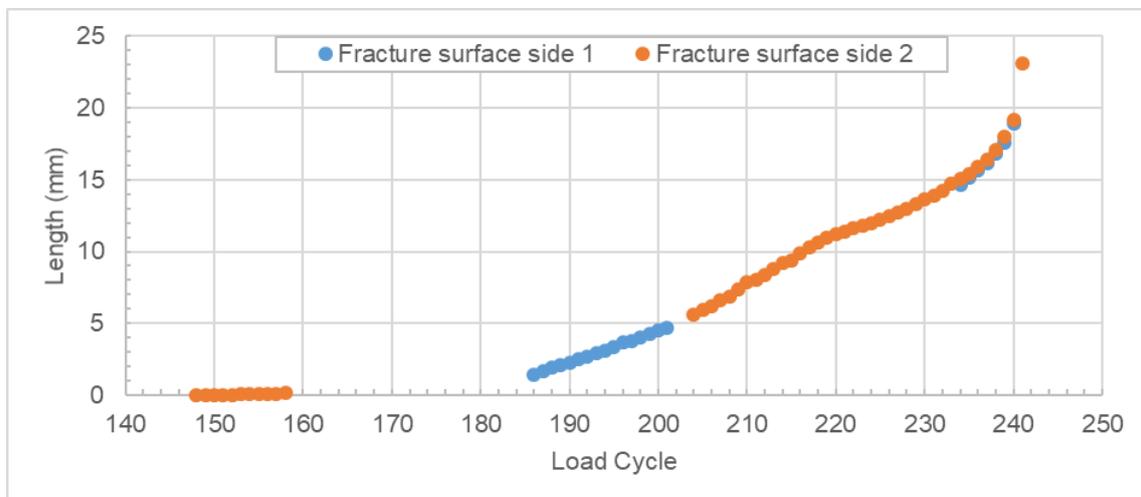
Fig. 9: Fatigue crack propagation from SEM and optical imaging
