Helicopter Main Gearbox Planet Gear Crack Propagation Test Dataset

A description of the dataset for HUMS2023 Data Challenge

A Description of the Dataset for HUMS2023 Data Challenge

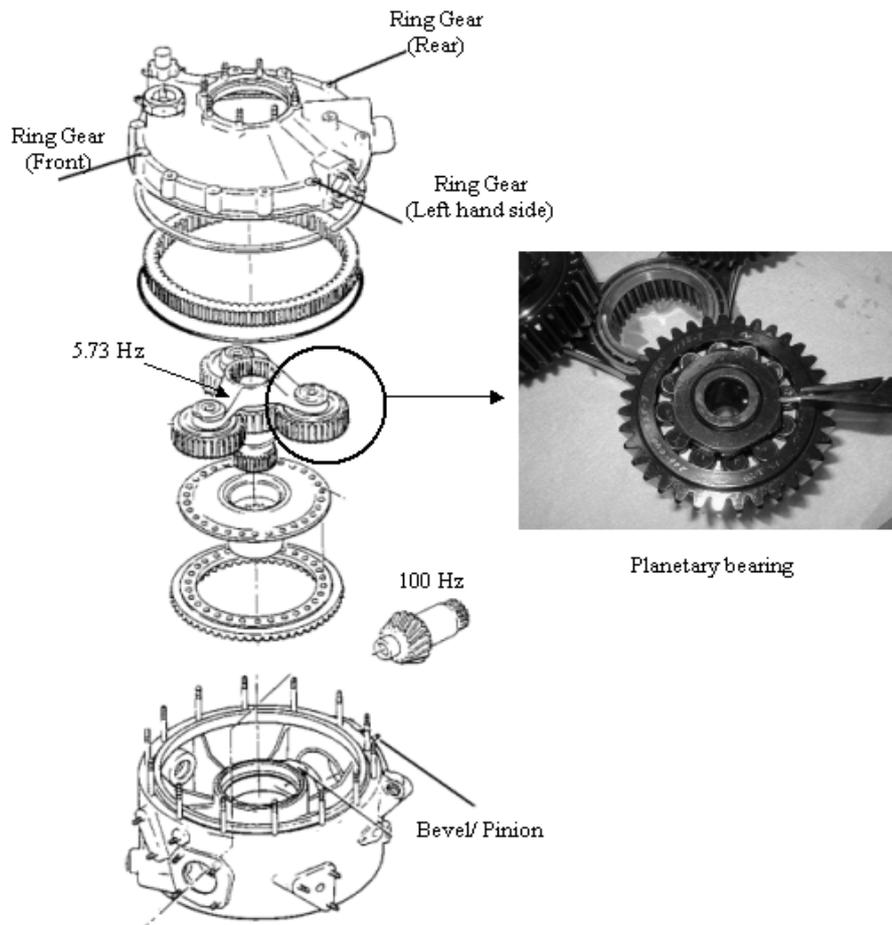
Figure 1 Bell 206B-1 (OH-58) main rotor gearbox (three-planet version). The four-planet version was used in the test. Four sensor locations are indicated in the figure.

An exploded-view diagram of the gearbox with sensor locations is shown in Figure 1. A cross-sectional view of the gearbox is shown in Figure 2. These figures actually show the three-planet version of the gearbox, but the configuration is essentially the same for the four-planet gearbox apart from detail differences in the planet carrier, planet gears and bearings. Note that the spacing of the planet gears in the four-planet version is not quite equal due to kinematic constraints.

The accelerometer locations are listed in Table 3 (also refer to Figure 1). The sensitive axes of the ring gear accelerometers were radially aligned to the planetary stage, and the input gear accelerometer was radially aligned to the input shaft. A once-per-rev tachometer reference signal from the input shaft was used in the synchronous averaging process.

Table 3 Accelerometer locations (also ref to Figure 1)

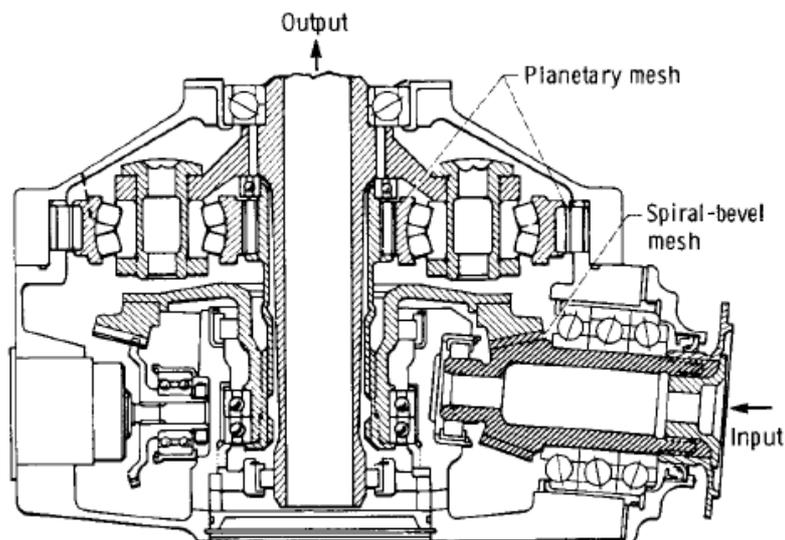
Figure 2 Bell 206B-1 (OH-58) main rotor gearbox (three-planet version) [from Lewicki & Coy (1987) <https://ntrs.nasa.gov/archive/nasa/casi.ntrs.nasa.gov/19870011122.pdf>].

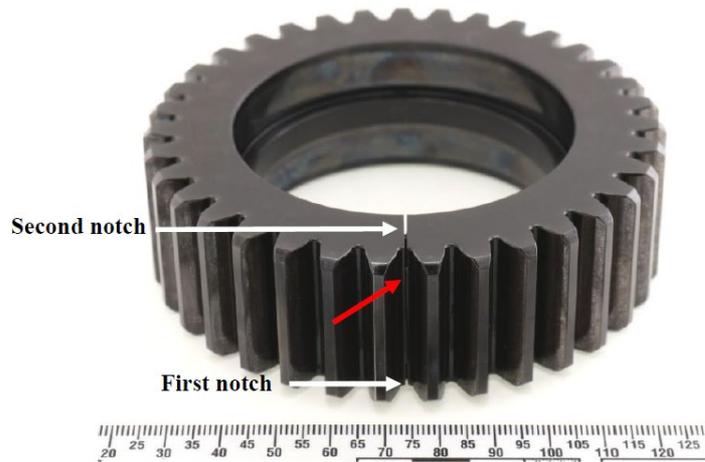
Figure 3 The cracked planet gear. The crack path is indicated by the red arrow.

The cracked planet gear is shown in Figure 3. There are two notches in the gear, one on each side. This is because the first (smaller) notch did not initiate a crack in the first 146 load cycles. The gearbox was then disassembled and a second (larger) notch was added on the opposite side. A fatigue crack was successfully initiated and propagated from the second notch over load cycles 147 – 241. The dimensions of the notches are shown in Figure 4.

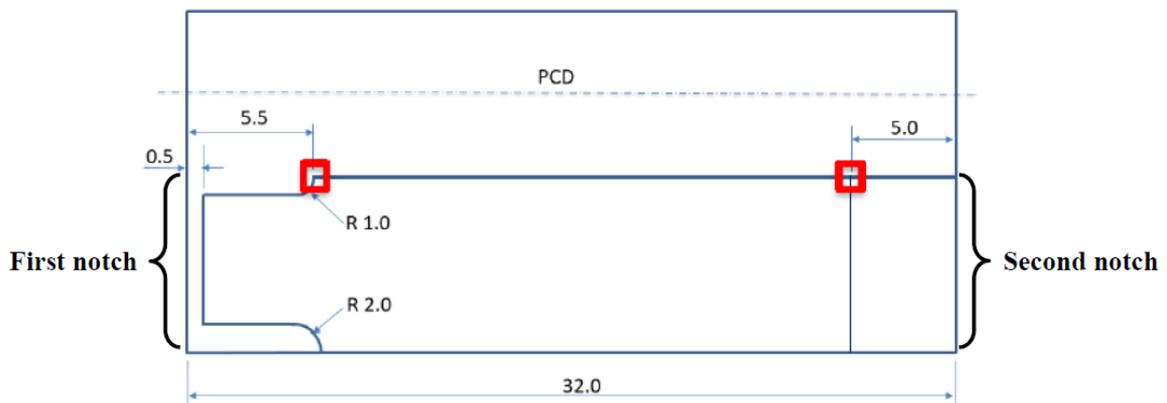
Figure 4 The notches in the planet gear (dimensions are in millimeters).

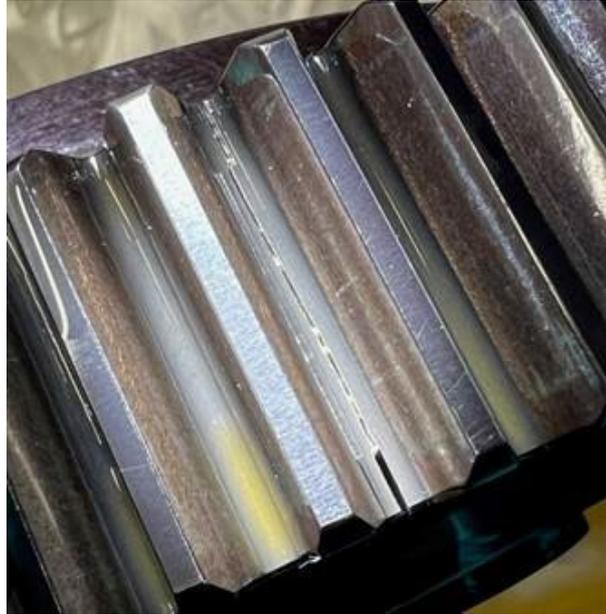
Figure 5 The complete crack viewed from the tooth top of the planet gear. The crack was propagated from the EDM notch at the bottom of the picture.

Two close-up views of the cracked gear are shown in Figure 5 and Figure 6. These figures show the final state of the crack, where it had propagated through the full width of gear body in the valley between the gear teeth. The planet gear was subsequently sectioned for a post-test analysis of the fracture surface to estimate the crack propagation versus load cycle.

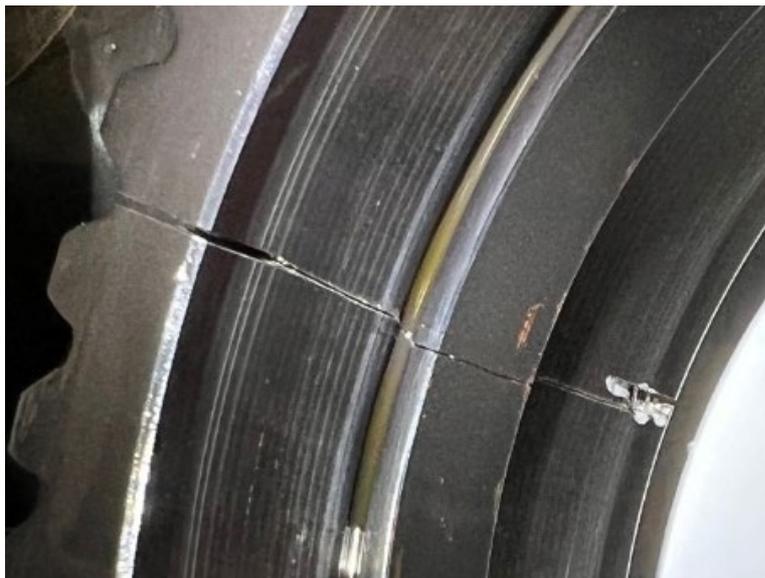
Figure 6 The complete crack viewed from the inner bore of the planet gear (the outer raceways of the double planet bearing). The crack was propagated from the EDM notch on the left.
