RAAF AE2100D3 Engine Health Management

SGT Andrew Wade CSC
MScTech (Aviation)
AE2100D3 EHMS
ALSPO Propulsion Systems Engineering
Royal Australian Air Force

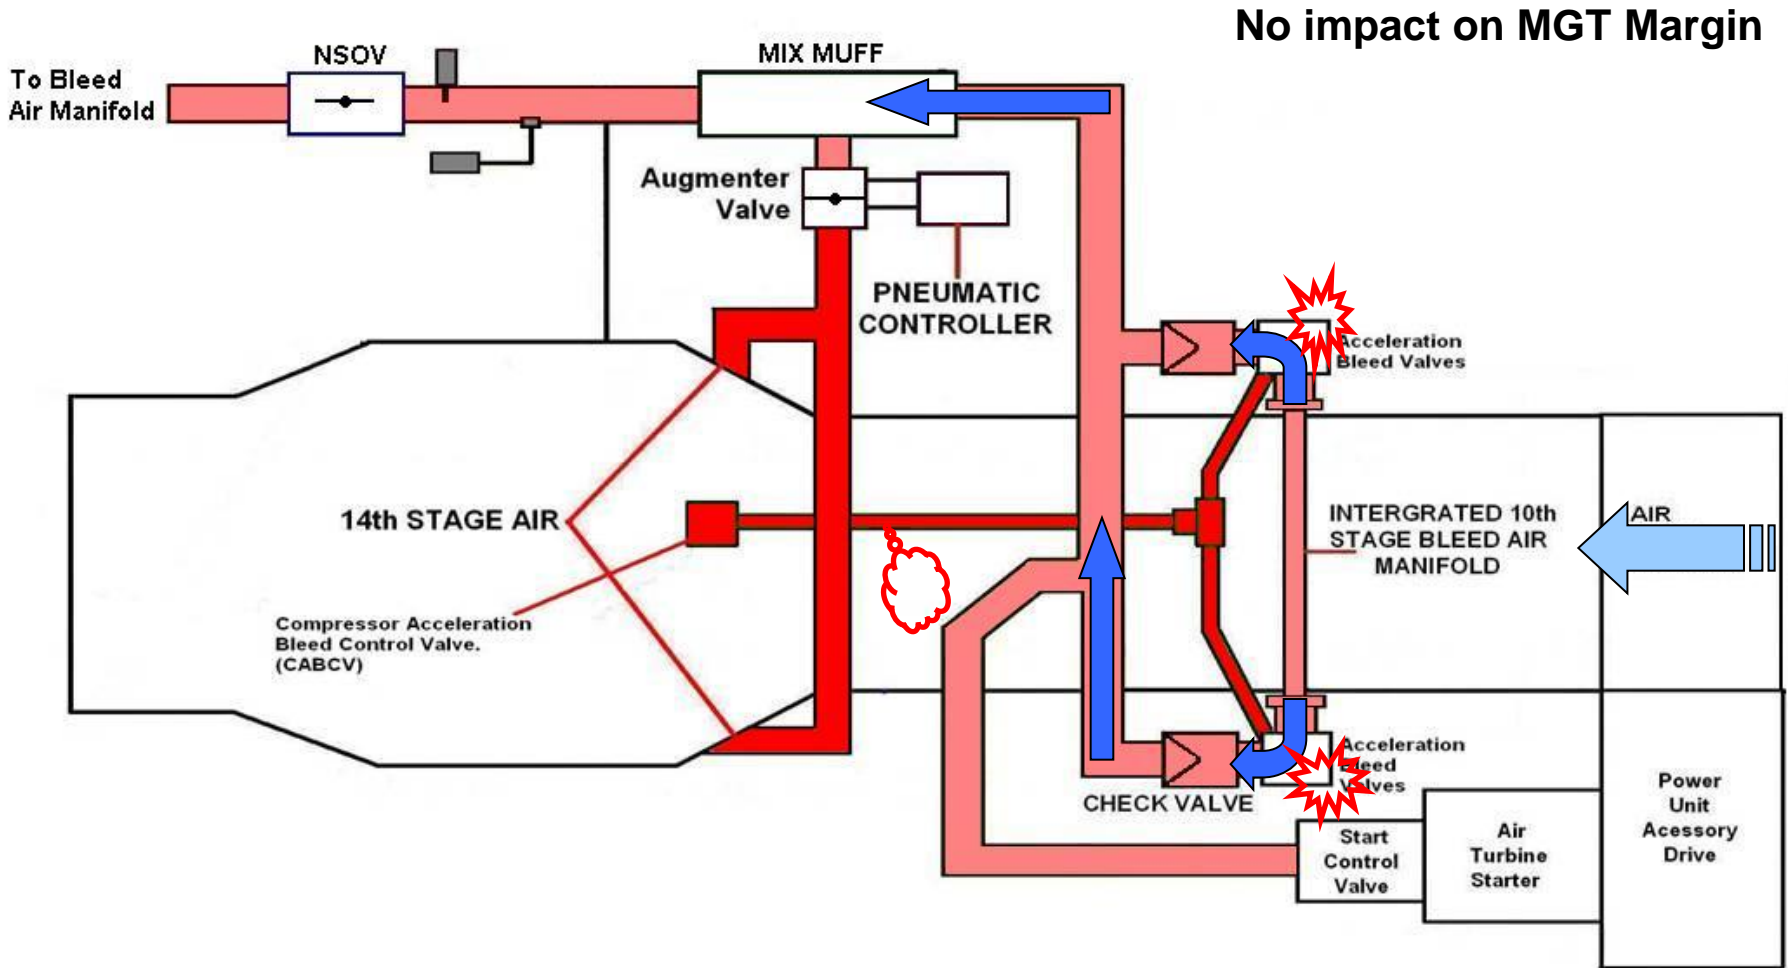
10th Stage Air – Partially open ABVs

² No real noticeable effect on performance (corresponding MGT / FF / NG shift) until MGT Margin is <5°C or CDP is <140 psi (>30% delta). The most likely contributor to this fingerprint is a pressure drop across 14th stage control air plumbing (leak in the CDP system) causing 10th Stage Acceleration Bleed Valves (ABV) to partially open. This leak in the CDP system is caused by worn ABV rings and/or springs, a split/leaking compressor wash air line or an excessively worn piston in the Compressor Acceleration Bleed Valve Control Valve (CABCV). Fault is confirmed by using compressed air to leak check the 14th Stage control air plumbing via the compressor wash air line fitting located in drain mast and the at fault item is replaced.

Small pressure drop in 14th stage control air plumbing
- CDP loss <30% Delta

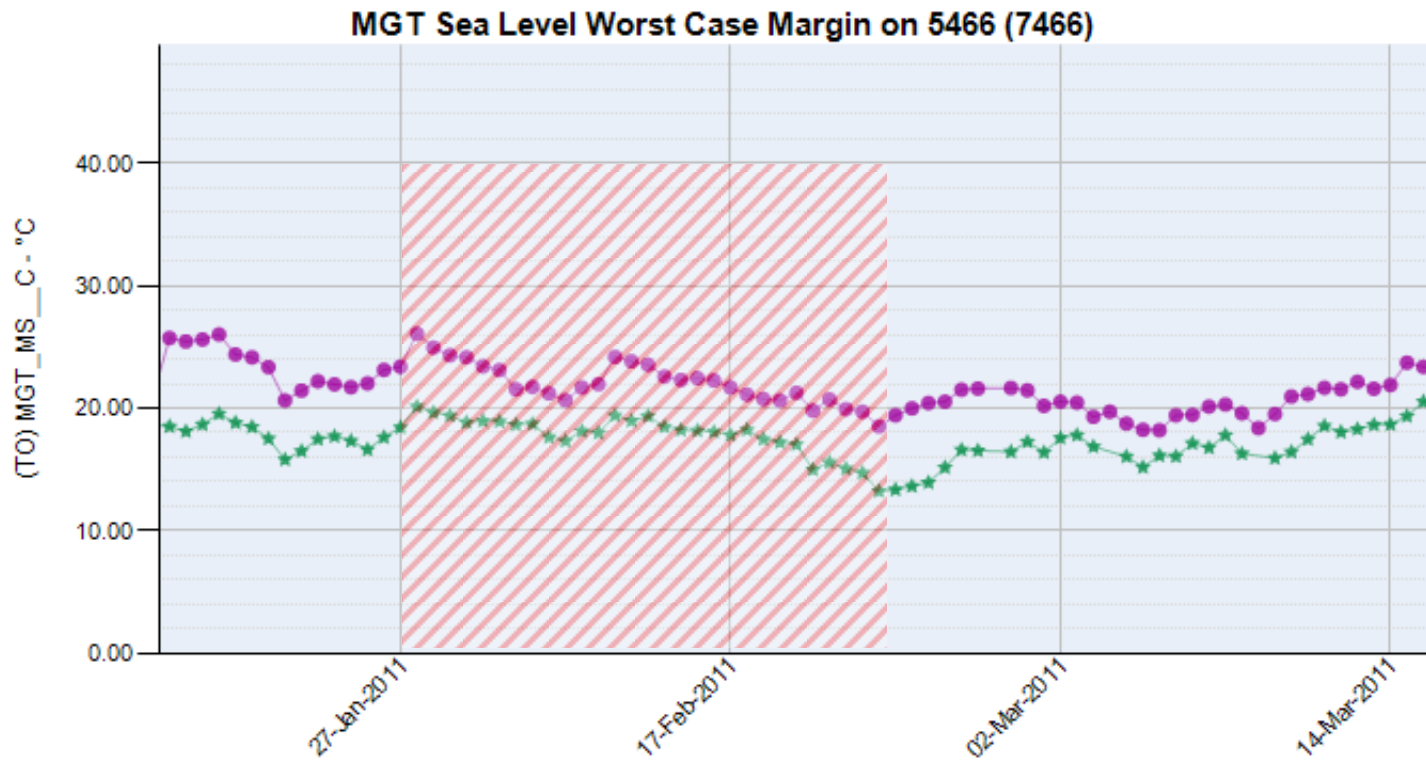
Example. 27 Jan - 20 Feb, 2011

CDP Step Change <30% Delta - Partially open ABVs

No MGT Margin Shift – Parallel movement

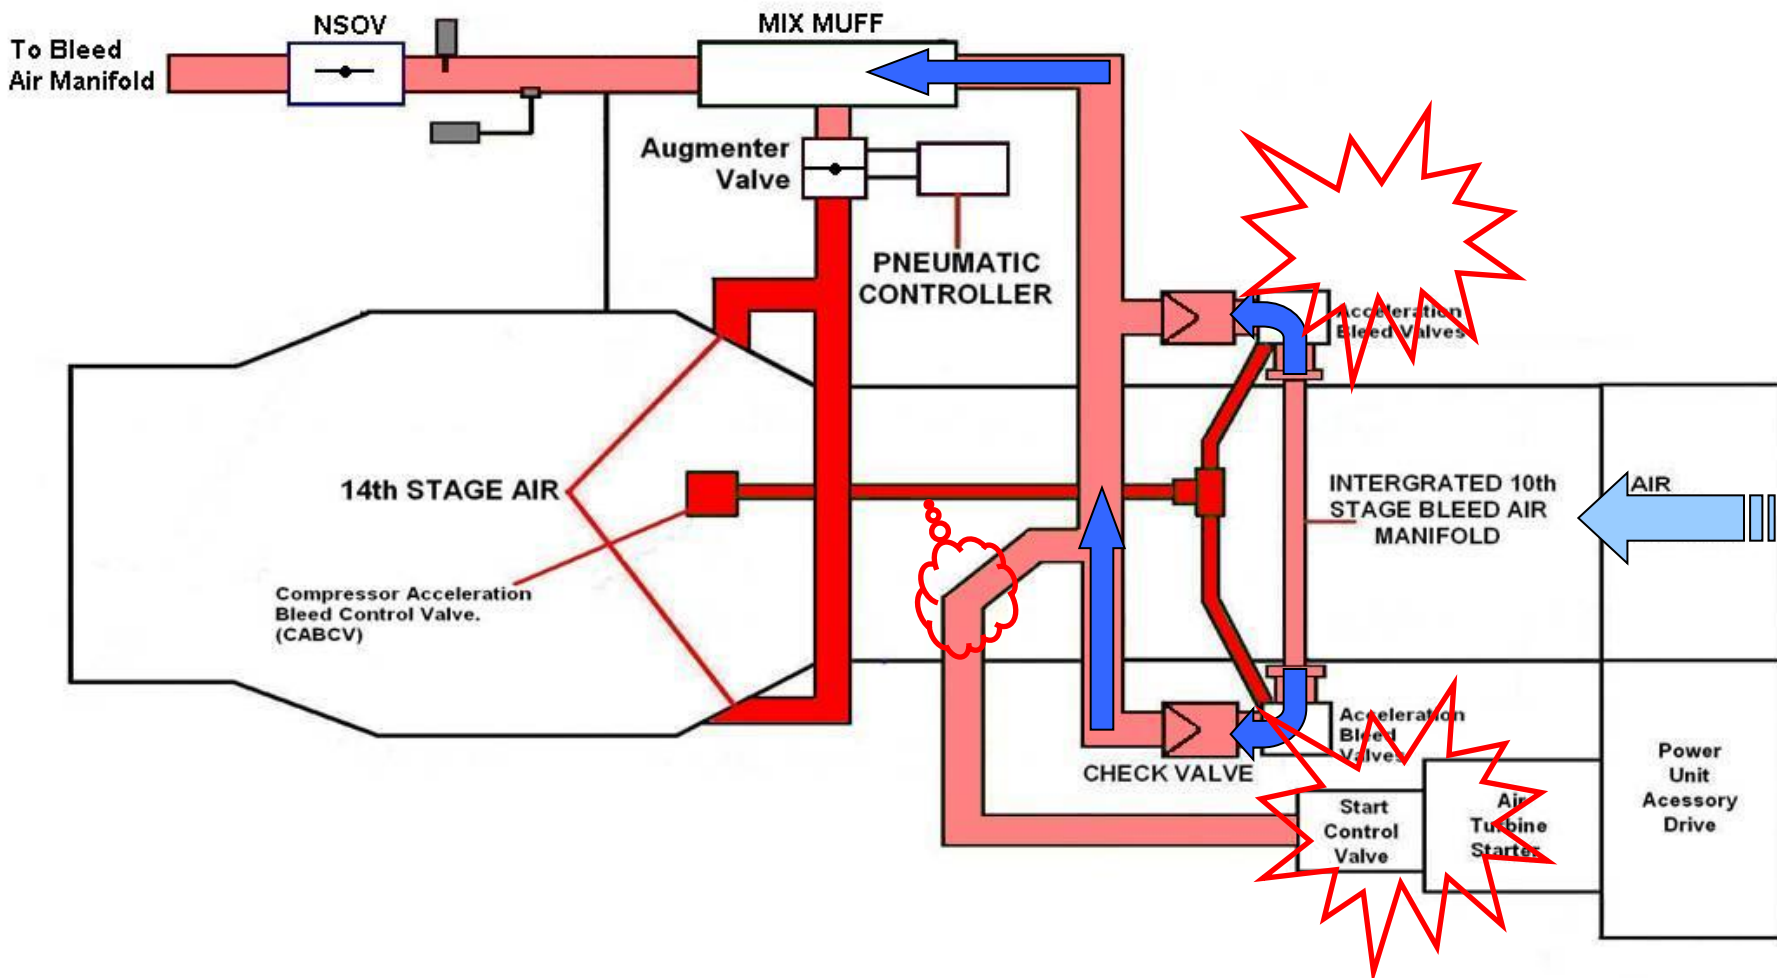
10th Stage Air – Fully open ABVs

³ Noticeable effect on performance as evidenced by a corresponding MGT margin and FF shift. The most likely contributor to this fingerprint is complete pressure loss across 14th stage control air plumbing causing 10th Stage Acceleration Bleed Valves (ABV) to fully open. This is caused by loose/disconnected 14th stage control air plumbing, loose/disconnected compressor wash air line (maintenance error) or one of the aforementioned plumbing has completely ruptured (structural failure). Fault is confirmed via visual inspection for loose/disconnected fittings or structural defects. If not able to be identified, compressed air is used to leak check the 14th Stage control air plumbing via the compressor wash air line fitting located in drain mast and the at fault item is replaced.

Large pressure drop in 14th stage control air plumbing
- CDP loss >60% Delta

Significant MGT Margin loss

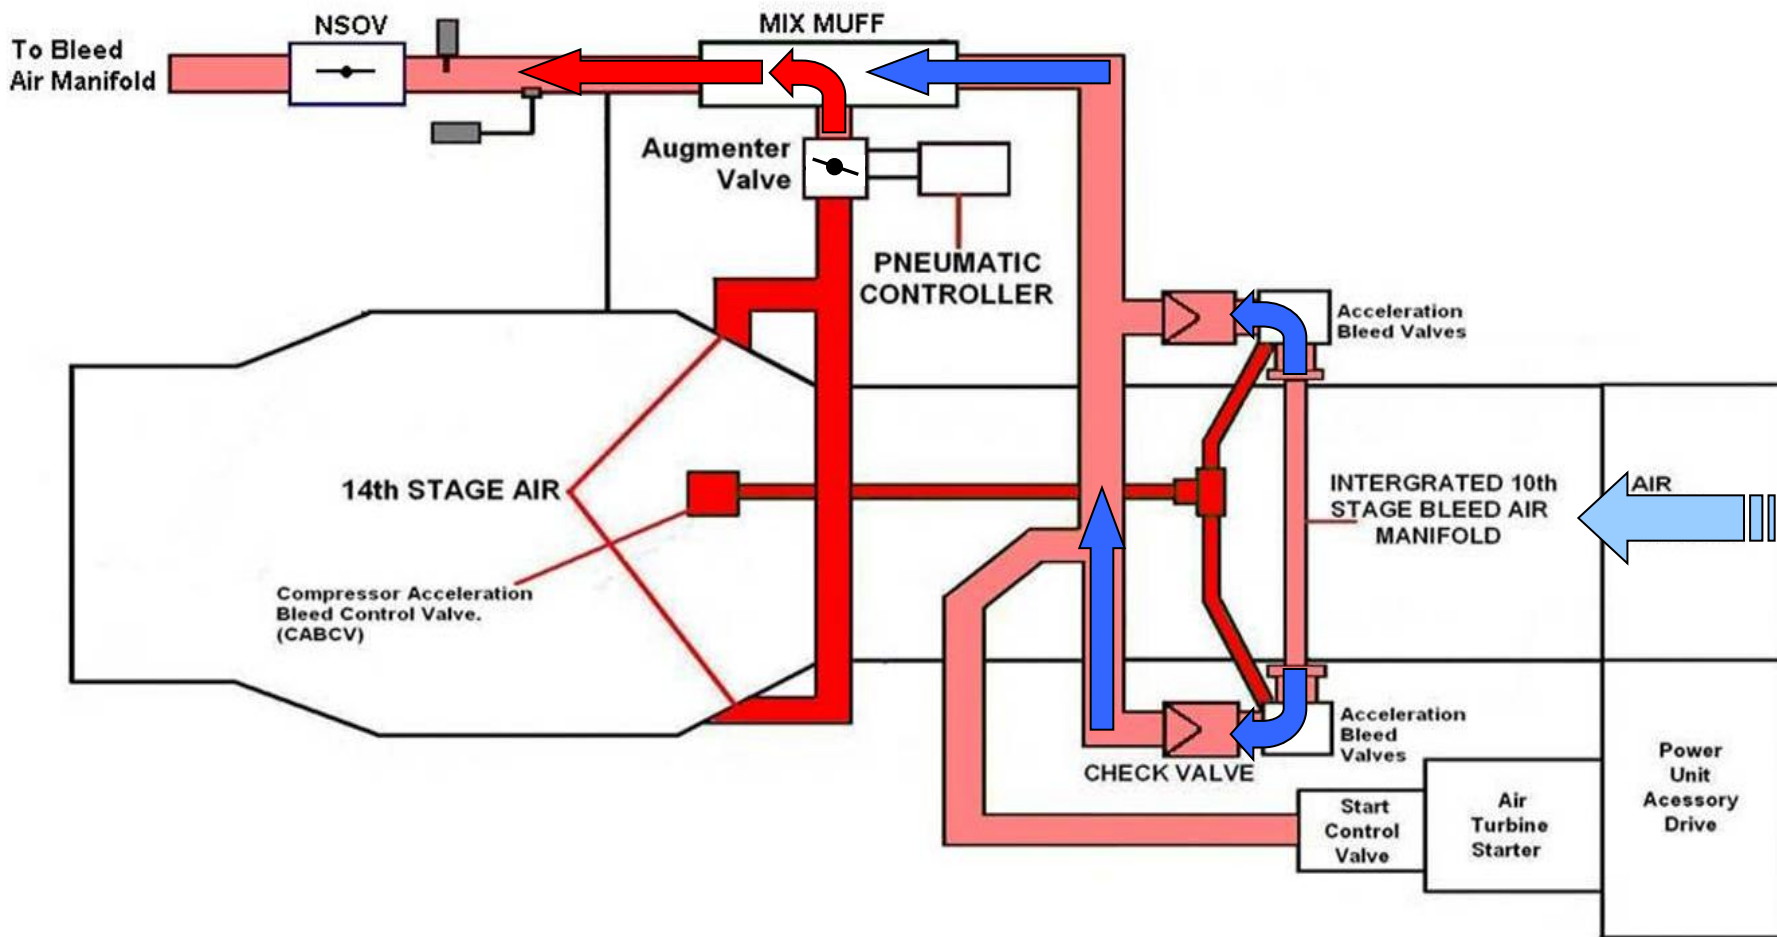
14th Stage Bleed Leak

⁴ This fingerprint will be characterised by a rapid fall in hours remaining until zero MGT margin over a short period of time. For example, if an engine displays a reduction in hours until zero MGT margin from >5000 hours to 1500 hours over a period of one week, and this fingerprint is displayed, then the most likely contributor is the 14th Stage Augmentor Valve being partially open at all power settings. This failure mode disrupts essential 14th stage turbine cooling air from the compressor, thereby increasing MGT and accelerating turbine degradation. When fault is confirmed (via 14th stage duct bleed air test kit), Augmentor Valve is replaced.

Partially open Augmentor Valve

- MGT Margin loss >15°C

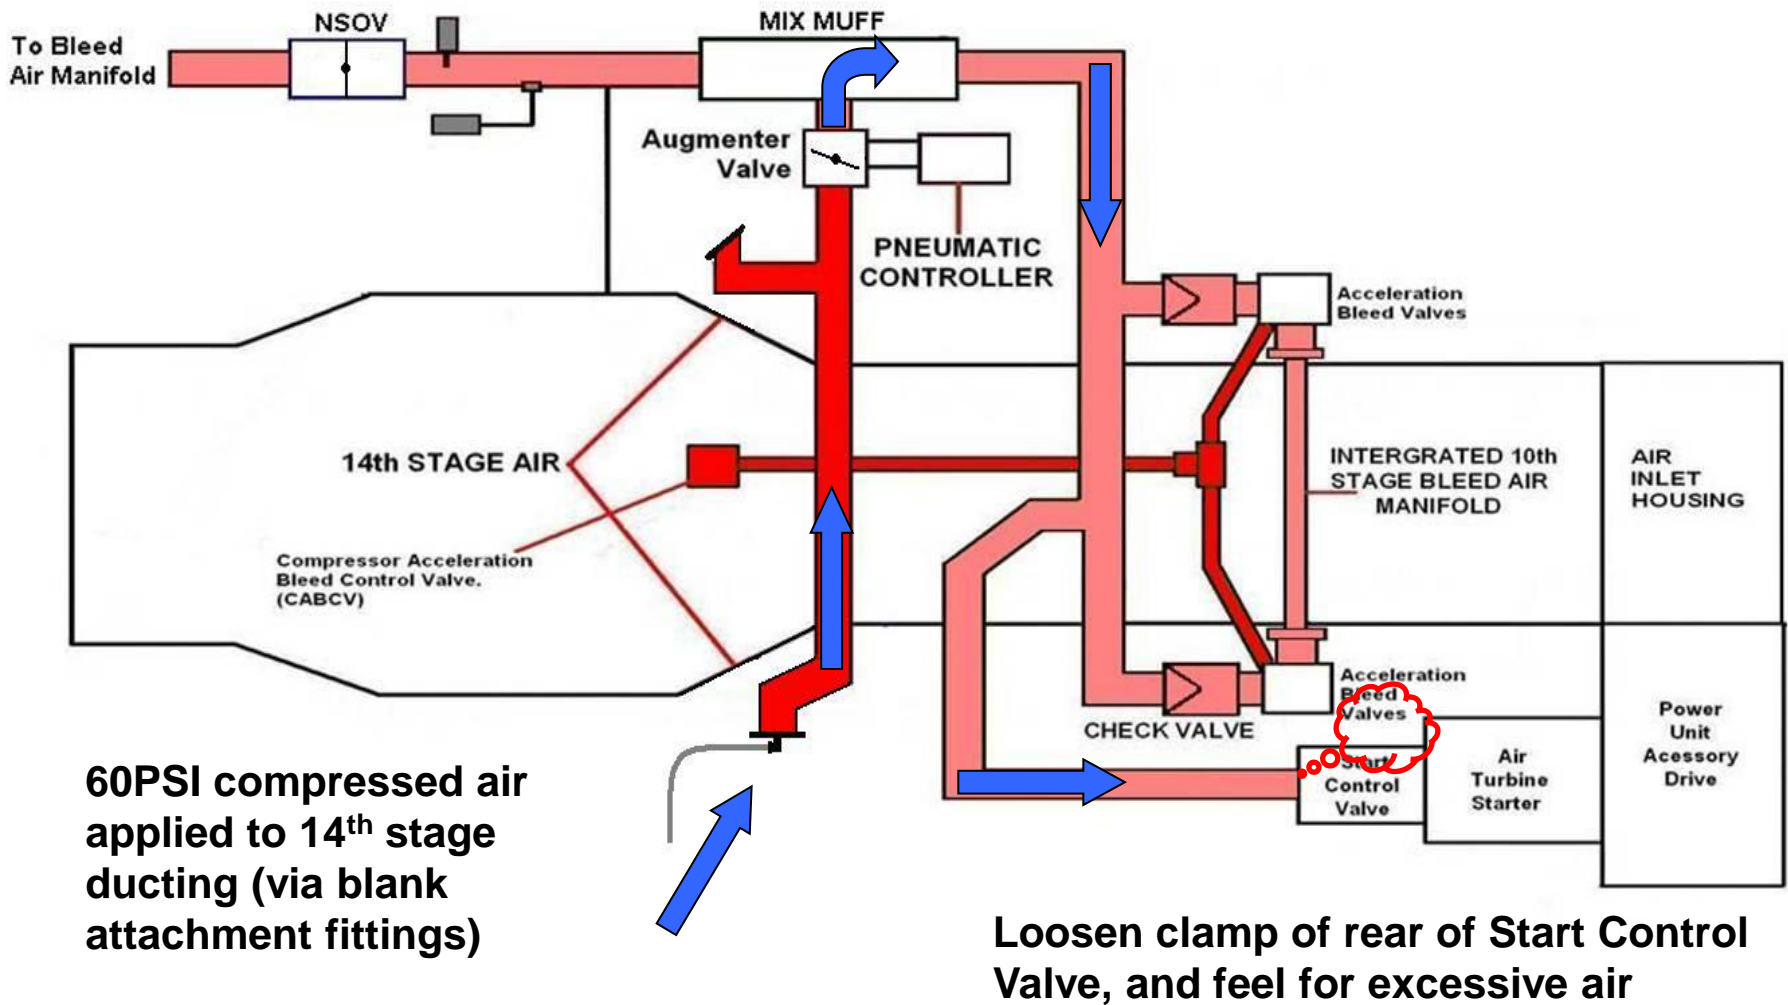
14th Stage Augmentor Valve Check

- Partially open valve causing $>15^{\circ}\text{C}$ MGT Margin loss.
- Fault confirmed via compressed air through 14th stage ducting.
- 30 Augmentor Valves removed in last 12 months for this failure mode.

Leak check using compressed air

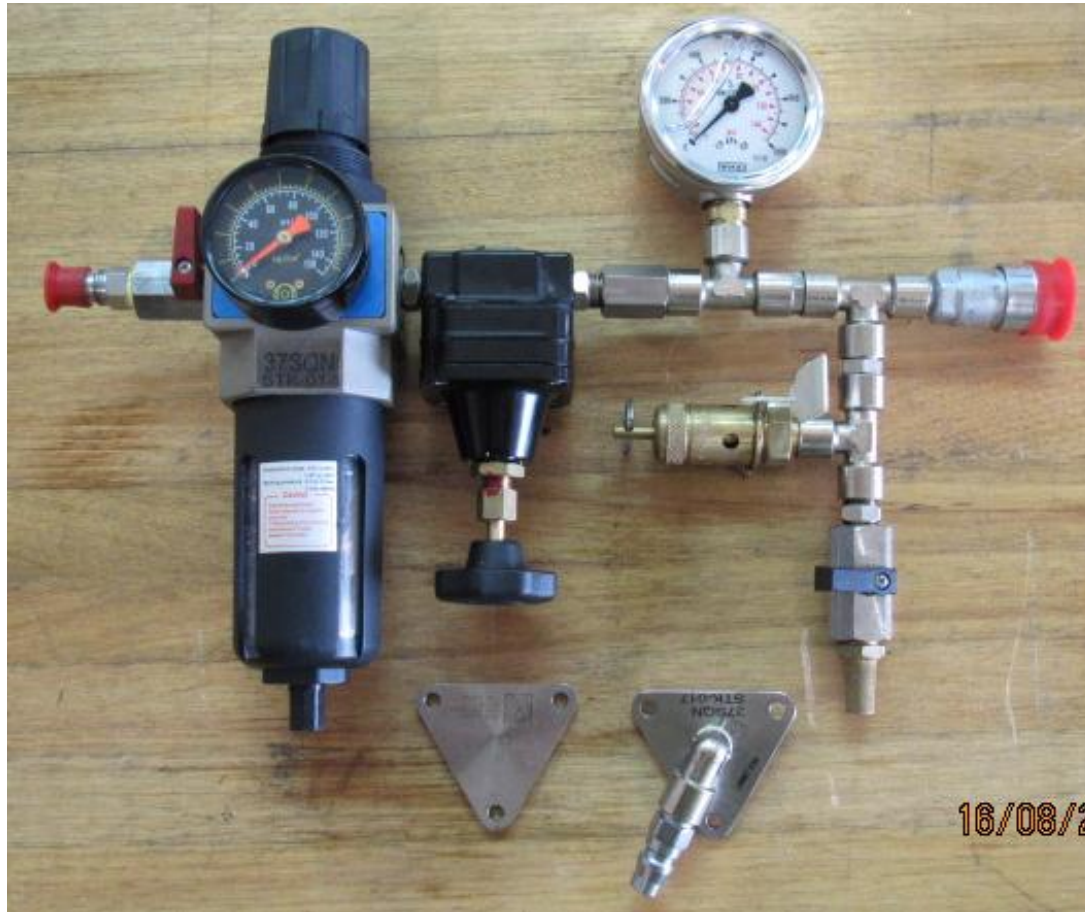
14th Stage Ducting

Compressed Air Test Kit

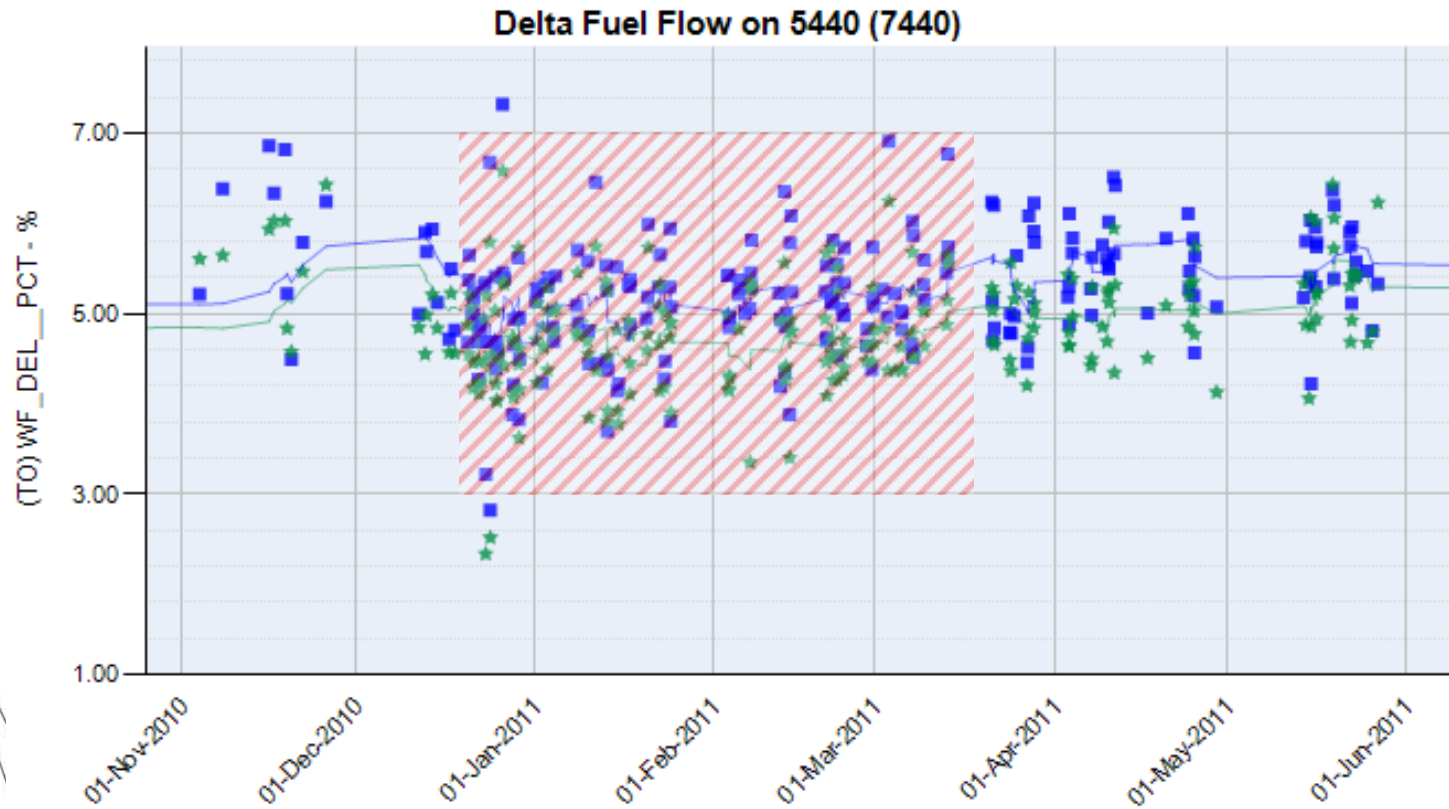
15°C MGT Margin Loss – Coked Fuel Nozzles

Fuel Flow – No noticeable increase

- Coked fuel nozzles causing $>15^{\circ}\text{C}$ MGT Margin loss are all Piloted Orifice variant. (No occurrences so far related to PuAB)
- Coked nozzles - confirmed via borescope inspection.
- 20 Fuel Nozzle sets (x 16) removed in last 12 months for this failure mode.
- All removed fuel nozzle sets had accrued ~ 1000 hours since last Bay Service (2400 hour BS interval)
