20th Australian International Aerospace Congress

DSTG Planet Gear Rim Crack Propagation Test

The Defence Science and Technology Group (DSTG) recently conducted a planet gear fatigue crack propagation test in a Kiowa 206B-1 helicopter main rotor gearbox (4-planet version). This test was designed to explore the phenomenon of fatigue cracking in thin-rim helicopter planet gears where the gear body incorporates the outer raceway of the planet bearing, and the crack initiates at or near the raceway surface and propagates through the gear body instead of a gear tooth. The crack was initiated from an electric discharge machined (EDM) notch in the planet gear rim and propagated from one side of the gear to the other between two gear teeth. This type of fault is challenging to detect reliably due to the lack of liberated wear debris, and the relatively weak vibration signature (using classical vibration fault detection methods) until the crack reaches across a large proportion of the gear body. As a result, this can lead to the catastrophic failure of the main rotor gearbox. The details of the test, selected results, and other issues are presented and discussed. A vibration dataset genera

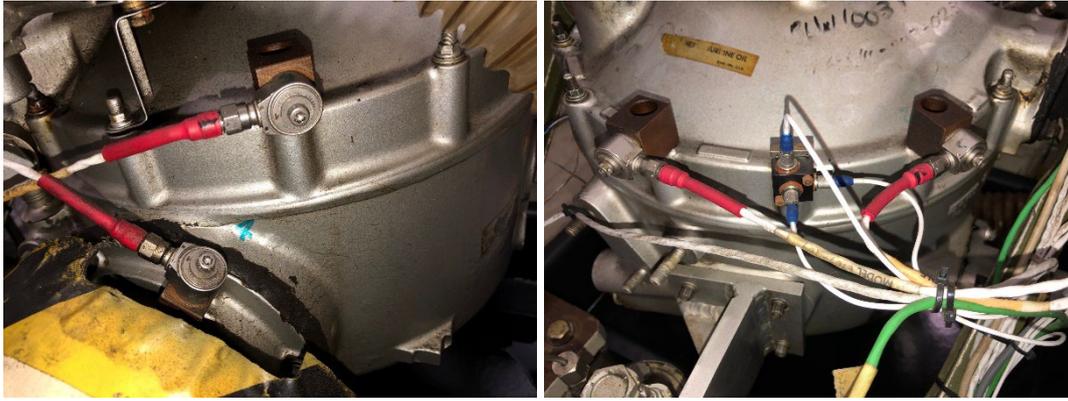
Fig. 3: Accelerometers as mounted on the gearbox

The gearbox was instrumented with four single-axis Endevco 6259M6-10 accelerometers and one tri-axial Endevco 2258A-100 accelerometer (Fig. 3). Inductive pick-ups provided 1/rev and 128/rev tachometer signals on the input and output shafts. Analogue voltage signals
