Determination of composite patch thickness on the accuracy of nondestructive testing of the repaired structure of PZL-130 ORLIK aircraft

Abstract

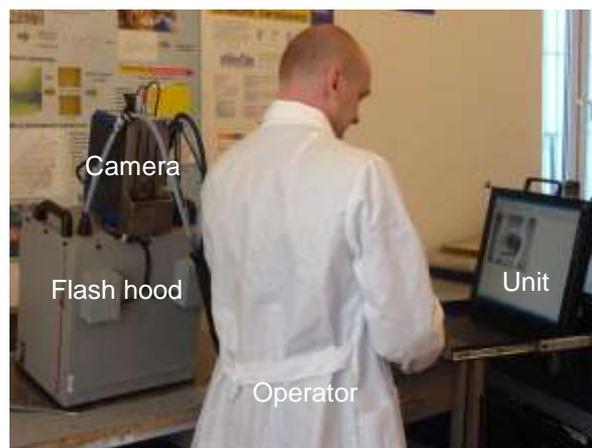
Fig. 5 EchoTherm Inspection system

The thermography NDI test used for inspection of the composite patch consists of inducing a high-temperature thermal impulse in the inspected object and recording of the material response. The impulse is produced by a set of strong electric flash lamps installed under the flash hood – the response is recorded by a camera. Recording and analysis of the response signal is performed by the processing unit (Fig.5).

Thermal WAVE IMAGING EchoTherm system and a FLIR SC7000 camera was used in the presented experiment, with the use of following parameters :

- Sampling frequency – 54,7 Hz;
- Flash lamp energy 5kJ;
- length of thermal impulse – 4,0 ms;
- exposure time – 5 s.

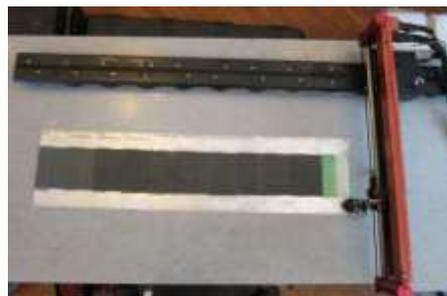
The UT, RT and MIA tests were made with the use of an automated MAUS V measurement system (Fig.8), which provides results in the form of C-Scan images.

Fig. 8 MAUS V
